INTERIM REPORT: INVESTIGATION OF LAND ADJOINING GLENSIDE & STEBBINGS ROADS, CHURTON PARK.

This report documents the preliminary findings of the archaeological investigation of the Stebbings Farmlands subdivision that adjoins Glenside and Stebbings Roads at Churton Park (Pt Lot 1 DP 63967 and Pt Lot 1 DP 60664). The investigation was carried out between 5 - 8 December 2005 in accordance with Authority 2006/122 granted by the NZ Historic Places Trust on 25 November 2005.

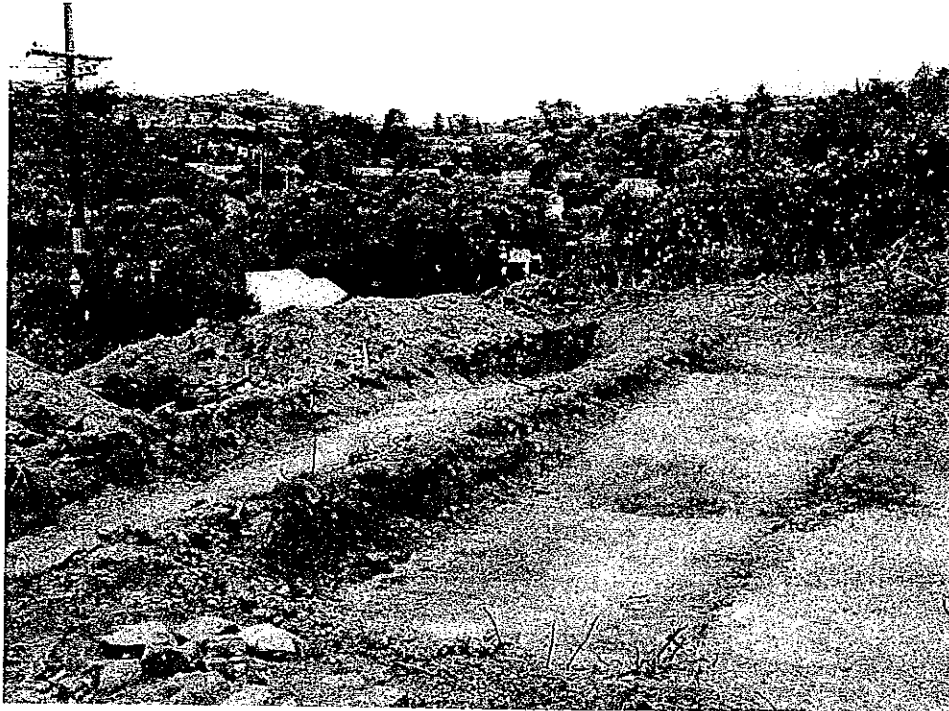
Trench No.1 was excavated from southwest to northeast along the outer edge of the terrace. A rubbish pit containing fragments of ceramic and glass was noted at the southwestern end of the north wall of the trench. Eight post holes less than 1m apart (c.3 feet) were exposed running in a parallel row close to the northern wall of the trench. The post holes were between 15 -20cm in diameter. Outside the post hole alignment was a mound of large rolled rivers stones and brick, some with evidence of burning, which may be the remains of a fireplace (Figure 1).

Figure 1: Trenches on terrace, stone and brick mound (bottom left).

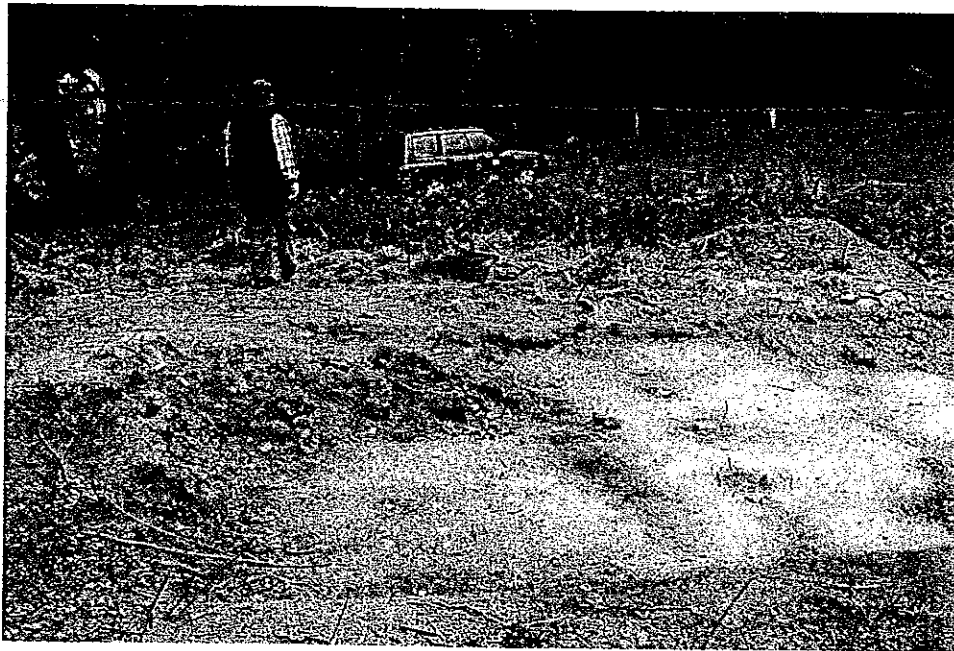
The third area, that lay between the brick "footpath" and the area of rubbish holes was stripped to a depth of c.10-15cm exposing four post holes containing broken bricks (Figure 2).

Figure 2: Cleared area on terrace, with brick paving (top left) post hole alignment (right) and mound (top right).

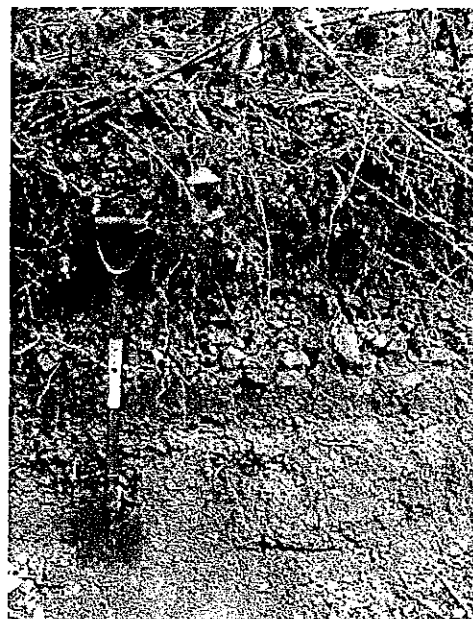
An area behind the old trees was said by local informants to be where an old house had been situated. This area is now covered with fill from the earlier work associated with the subdivision. A test pit 2m wide and 3-4m deep was excavated to the original surface by the digger (Figure 4). This test pit showed the disturbed material used for fill: clay/rocks, old iron, tyres, wood etc.

Figure 4: Test pit behind trees, note layers of fill.
