**Archaeology of R27/392, 1 Stebbings Road,  
Glenside, under Heritage NZ authority 2014/119, for  
Stebbing's Farmlands Ltd.**

**Kevin L. Jones**  
**Kevin L. Jones Archaeologist Ltd**  
**6/13 Leeds Street**  
**WELLINGTON 6011**  
**kenx1000@gmail.com**  
**22 August 2018**

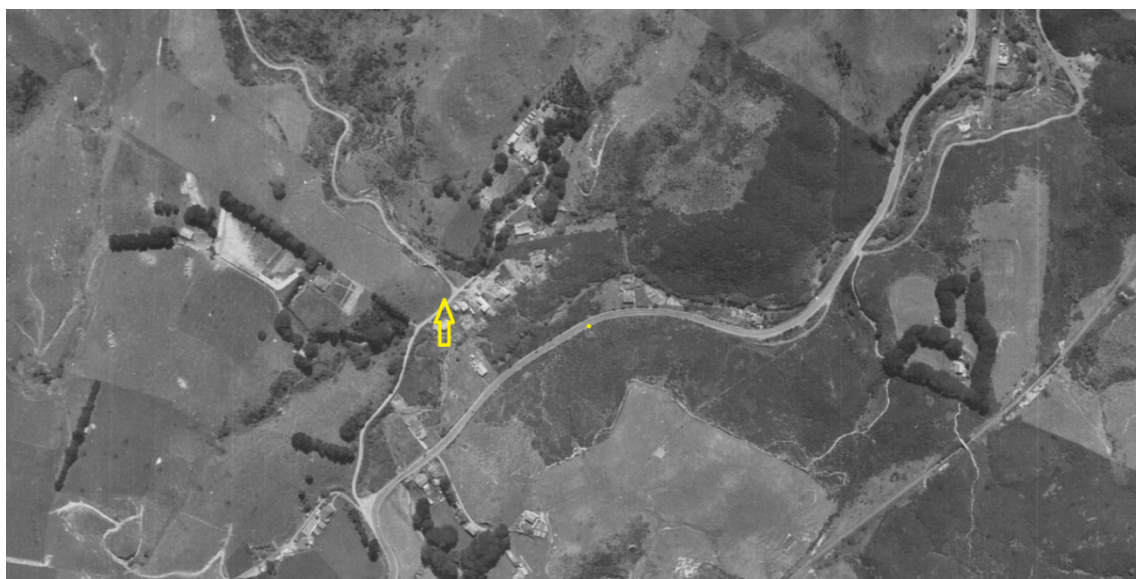
Fig. 2. 1941 aerial photograph showing 1 Stebbings Road and Archsite R27/392 site area (arrowed). Source Retrolens.

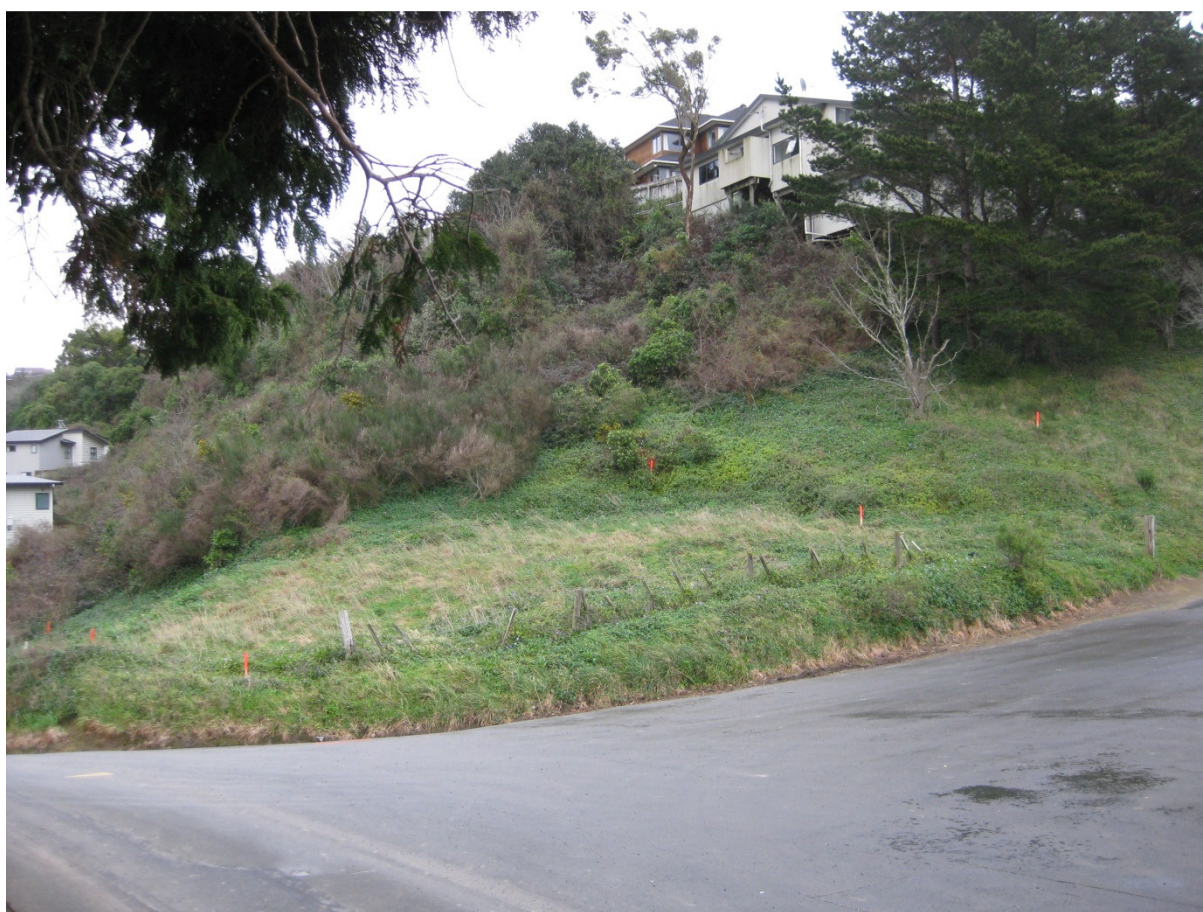
Fig 4. R27/392 prior to 2018 excavation, view from the east.

This is a small terrace at the intersection of what is now Glenside Road and Stebbings Road (Fig. 4). In 2005, this general area was test excavated under authority HP 2006/122 by Arczoo with a series of shallow trenches on Glenside Road (area 2 or B in the 2005 report) and a little further up the hill on an indistinct terrace (area 1 or A). The latter site area was partially excavated by Arczoo Ltd. It was identified as an early house site with some lines of pile holes and brick paving - and then sealed under a felted geotextile and partially buried.

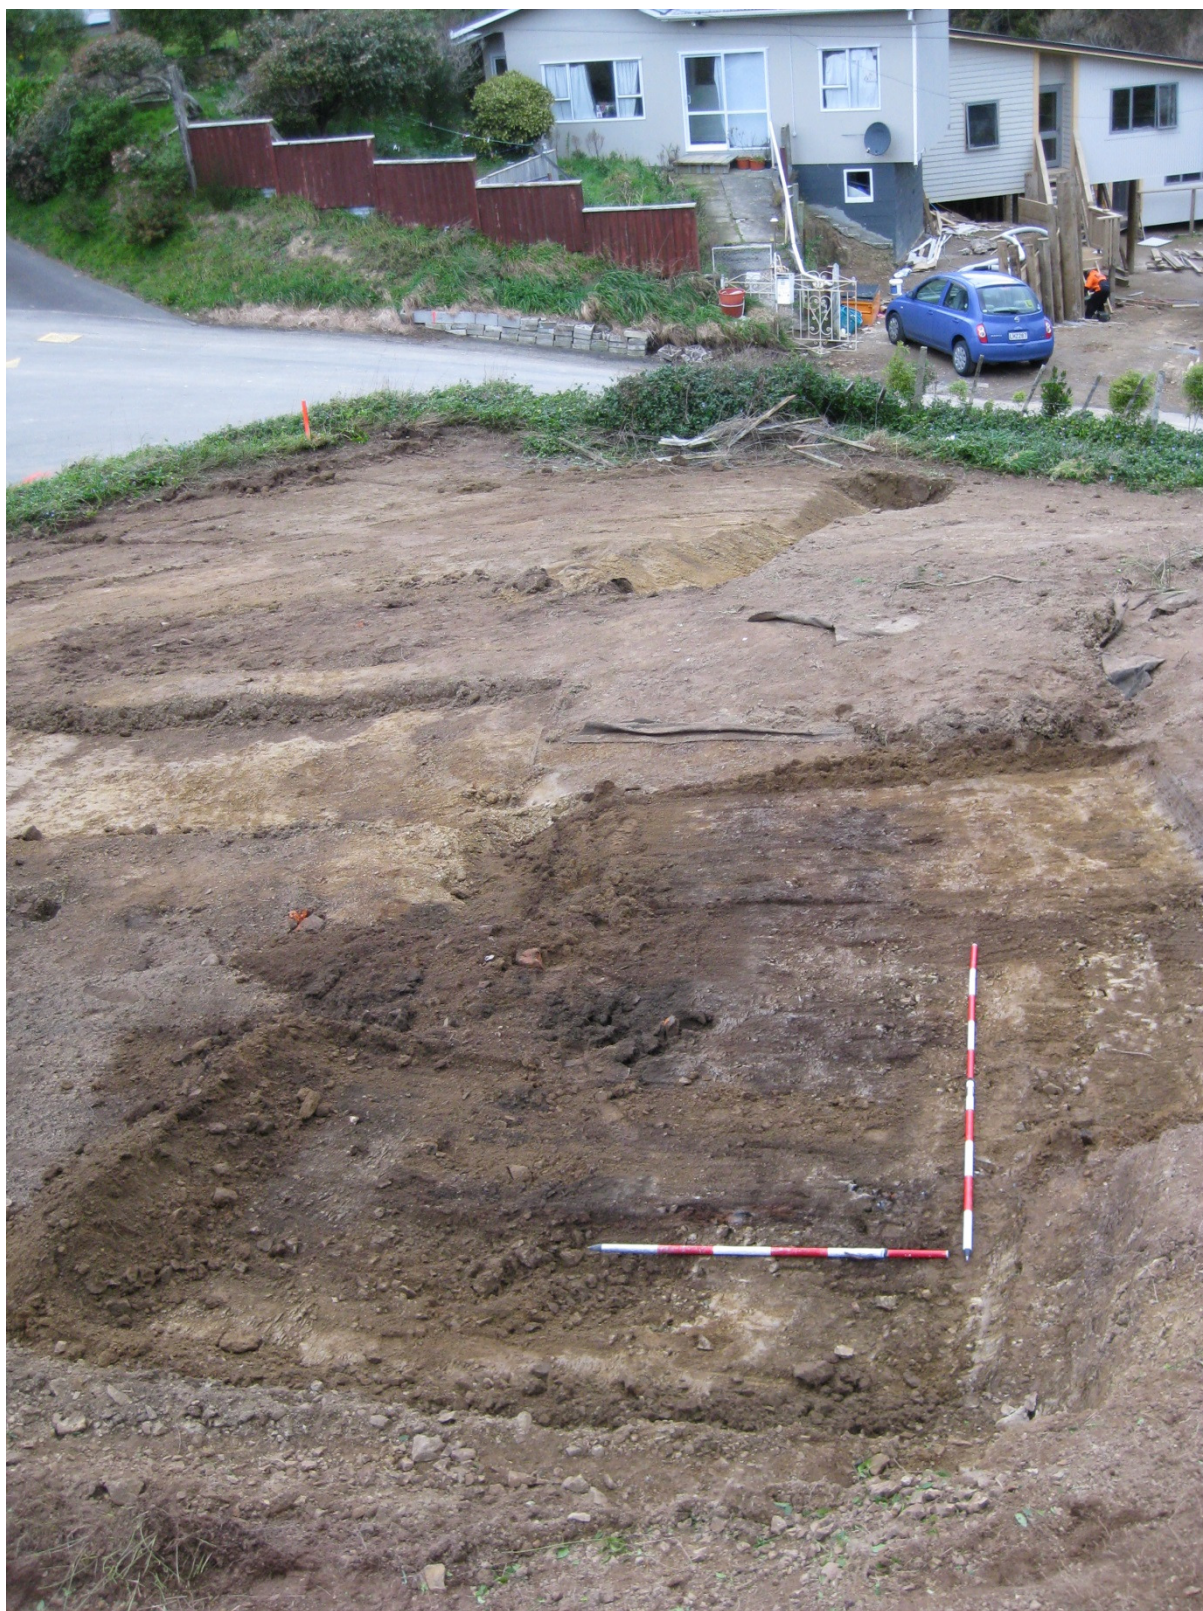
Fig. 8. Early stage of scraping, view to south-east, rectangular outline of lens of topsoil wash under the western corner of the cottage. Part of 2005 Opus Trench B centre left.

An initial finding was a rectangular area or pad of grey clay loam topsoil (Figs 5 - 8) in the western corner of the terrace and some artefacts including a complete cod bottle and fragments of further examples damaged by the digger. The 2005 plan shows this area as possible rubbish pits. It appeared to be soil wash under a rectangular section of the house, probably a lean-to (see below).

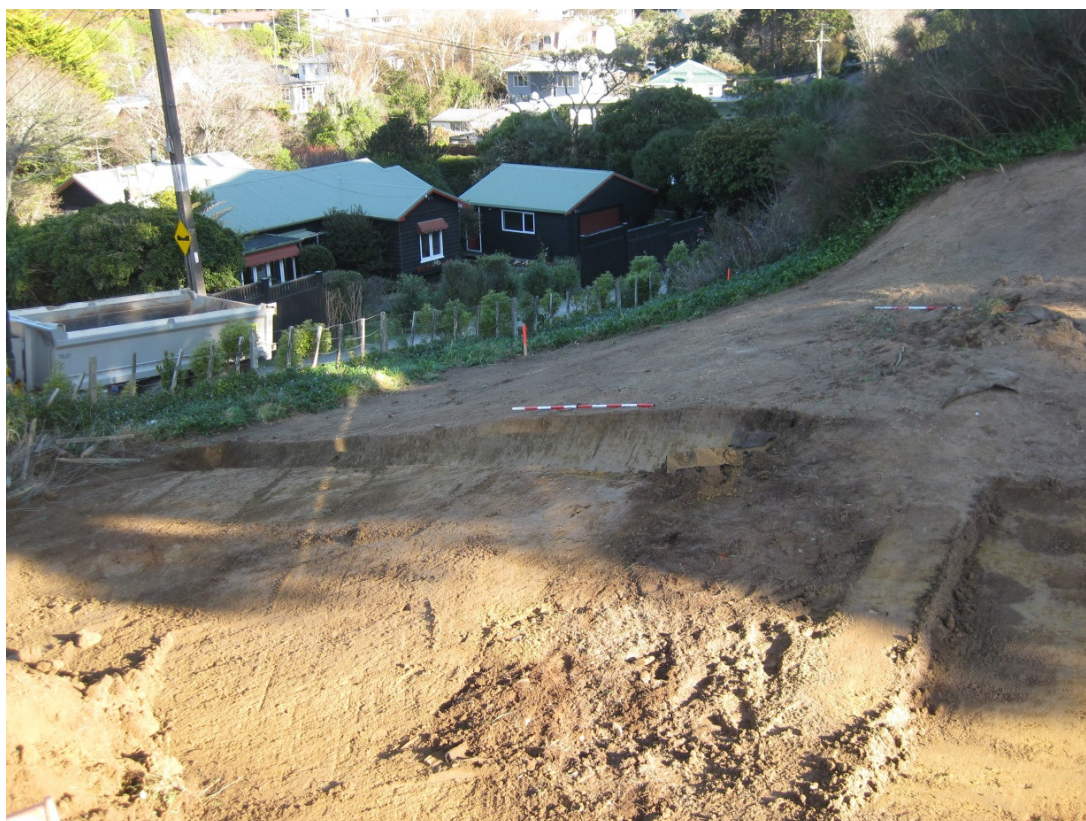
Fig. 10. Section K2 K3 down slope to south-east, the outlines of Arczoo trench A and trench B (dug out) in lower right half of the photograph.

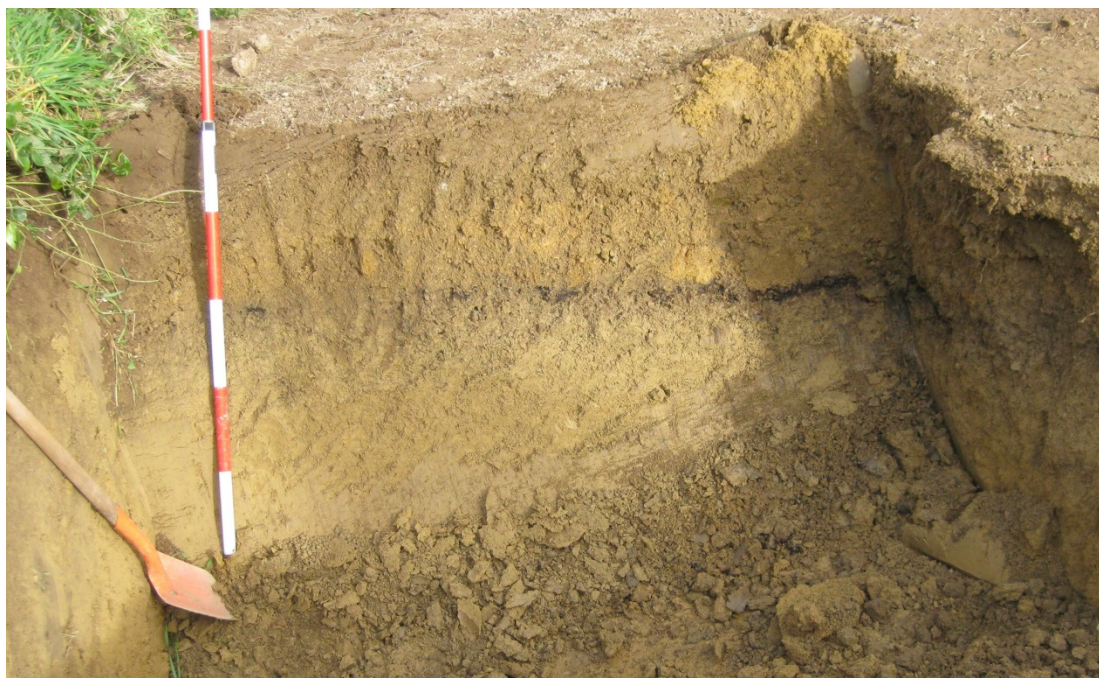
Fig. 11. Lower part of section K2 K3 showing weathered greywacke fill (from cutting for cottage?) over a charcoally soil. Silty clay subsoil at bottom. This is probably a backfilled Opus trench from 2005.

K2 K3 showed an even profile of natural clay subsoil down the slope. Near the Glenside Road fence the section showed a layer of weathered greywacke and clay over a thin lens of topsoil with clay loam to the base of the cut at about 100 cm below the surface (Fig. 11). This was initially puzzling and appeared to be perhaps an early formation for Glenside Road or a dray track. However, it seems most likely to be one of the Arczoo 2005 exploratory trenches, mapped in the 2005 plans as Area A. It is described as 'Area 2' in the 2005 report: 'trench 2 m wide and 30 m long was dug between the trees and the fence on the upper side of Glenside Road'.

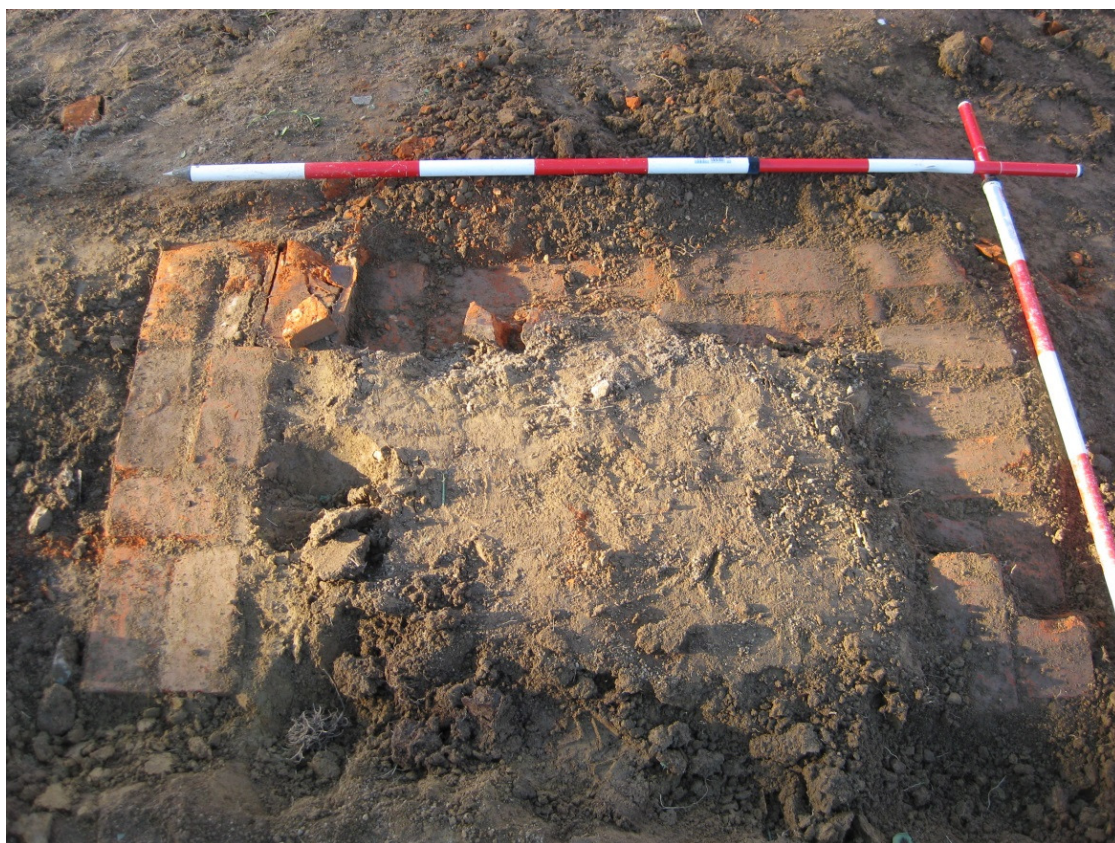
Fig. 12. Chimney/coal range placed-brick foundation, view to north-east.

On the house terrace, a brick chimney base was found on further stripping of the eastern end under an area where a disturbed brick area had been recorded in 2005. This area of brick foundation was three courses deep and 1.35 x 0.8 m in plan area and founded on solid subsoil clay (Figs 12 - 14). The bricks were very regular and tightly placed but not mortared. The foundation had an opening towards the interior of the house (i.e. it was a rectangle with wings). It is interpreted as a coal range foundation, comprised of an interior alcove for the coal range with an exterior brick chimney. Scattered towards the west were more frogged and plain bricks cast down a slight slope to the north-east which are interpreted as a collapsed chimney.

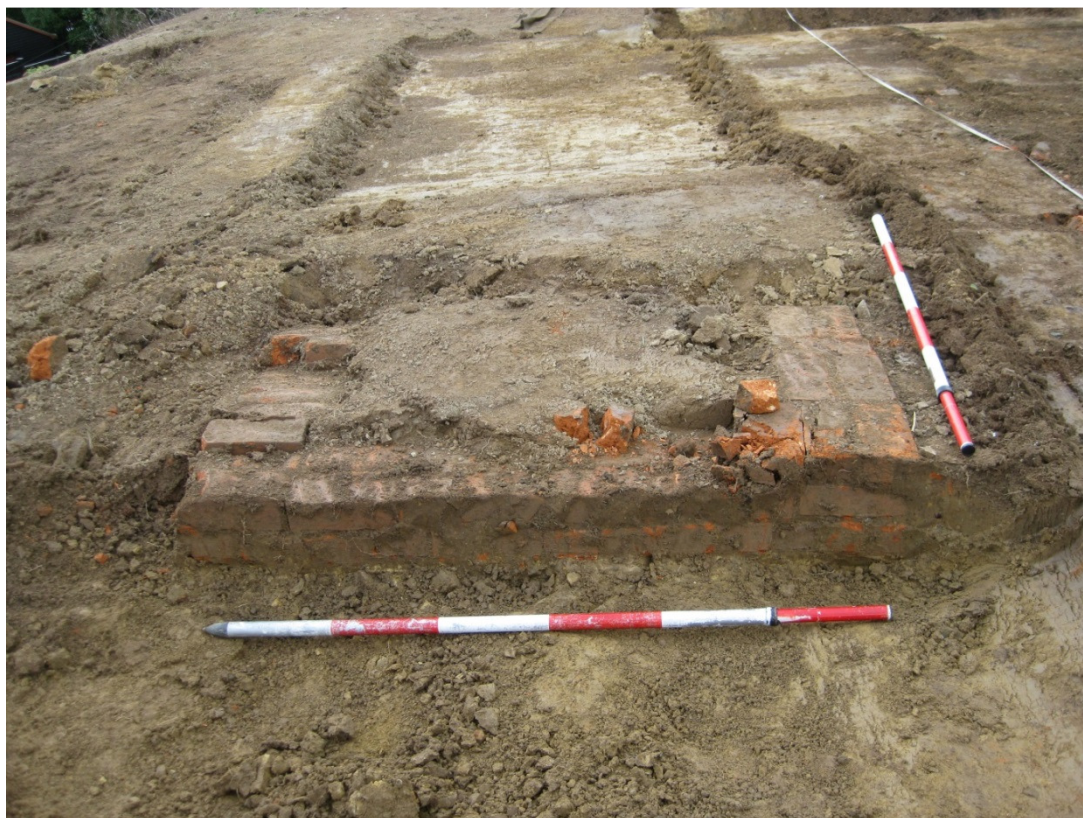
Fig. 13. Chimney/coal range placed-brick foundation, view to south-west.

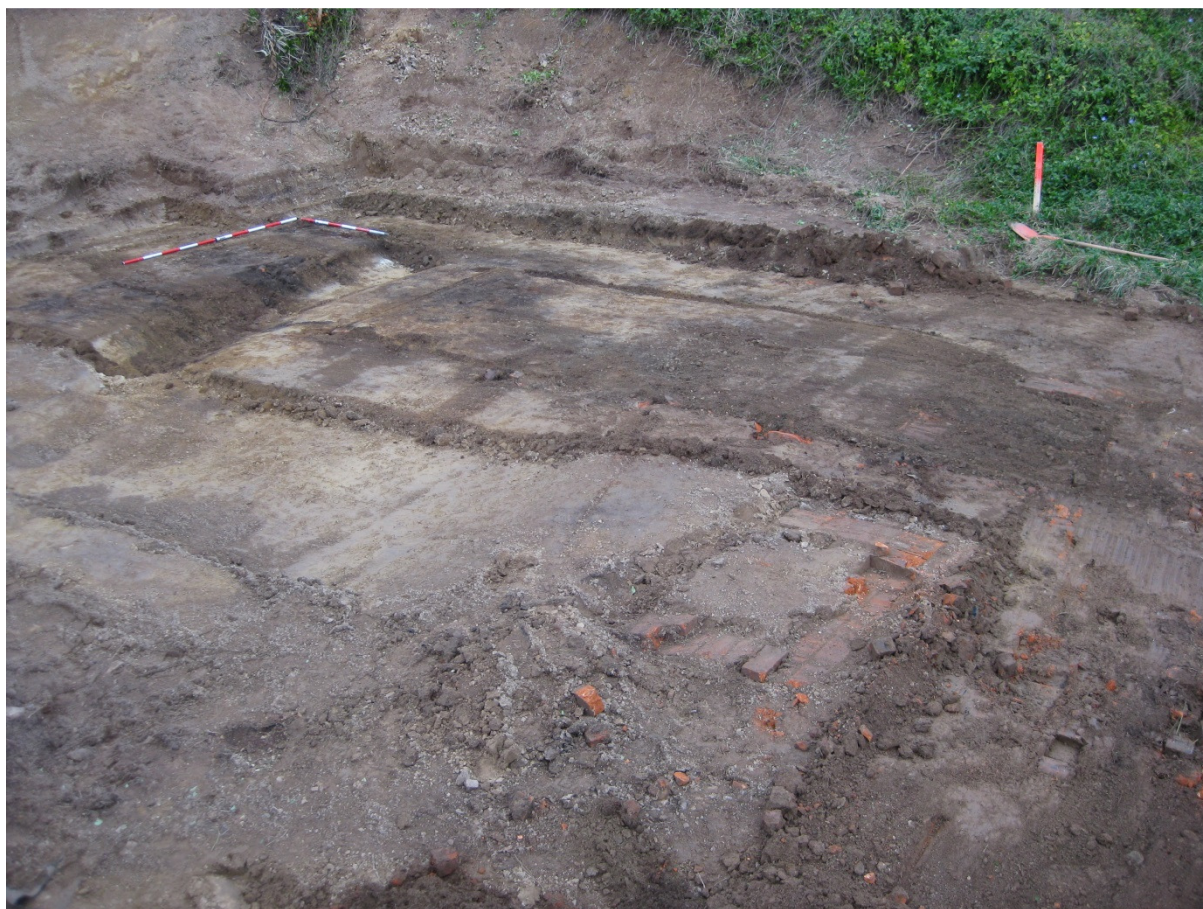
Fig. 14. View to north-west across site showing chimney/coal range base (lower right) and lens of soil wash (inside ranging poles) to the west.

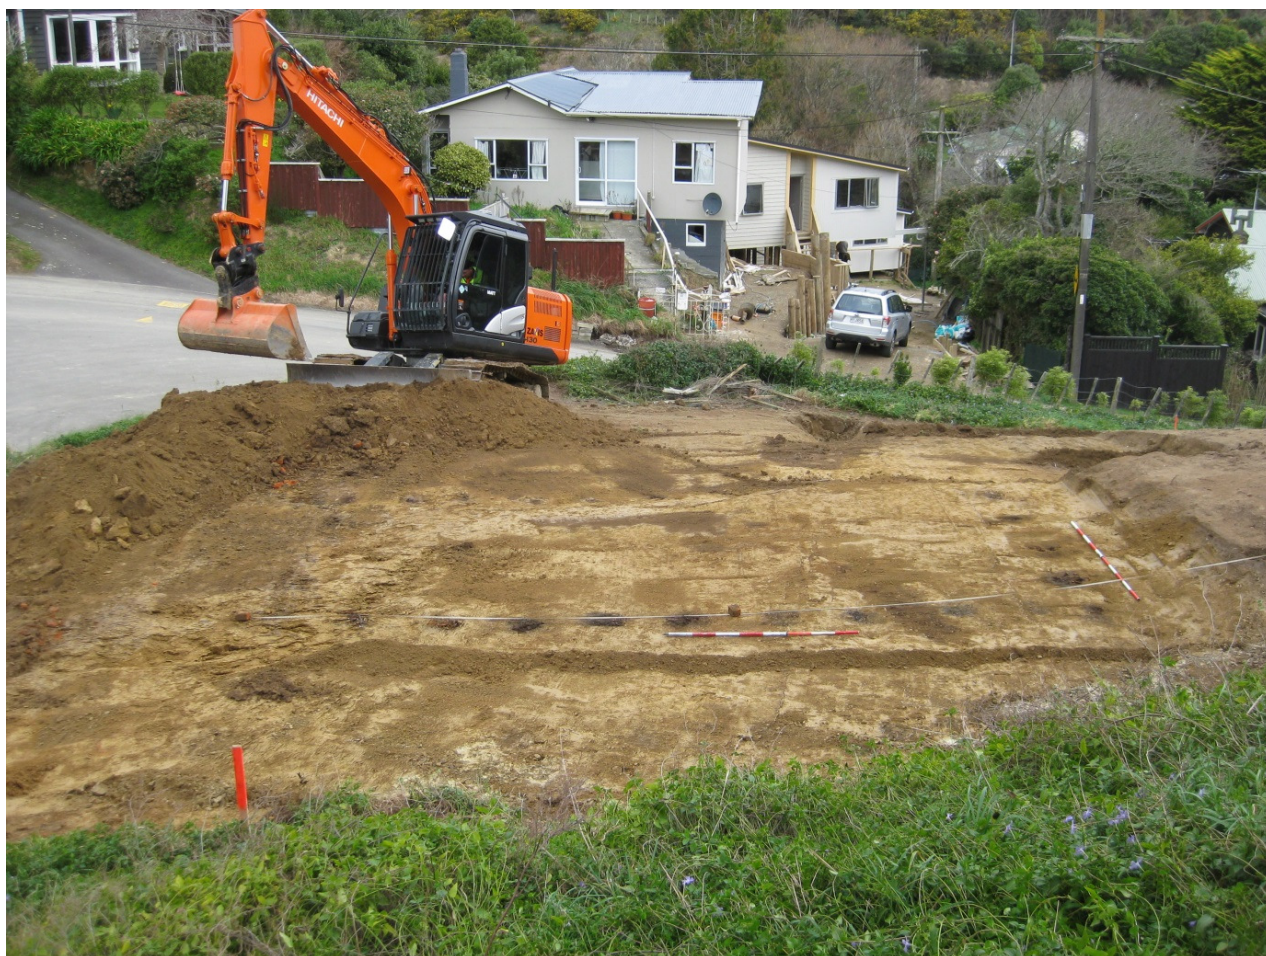
Fig. 15. Last phases of controlled excavation, central and south-west elevation pile holes.

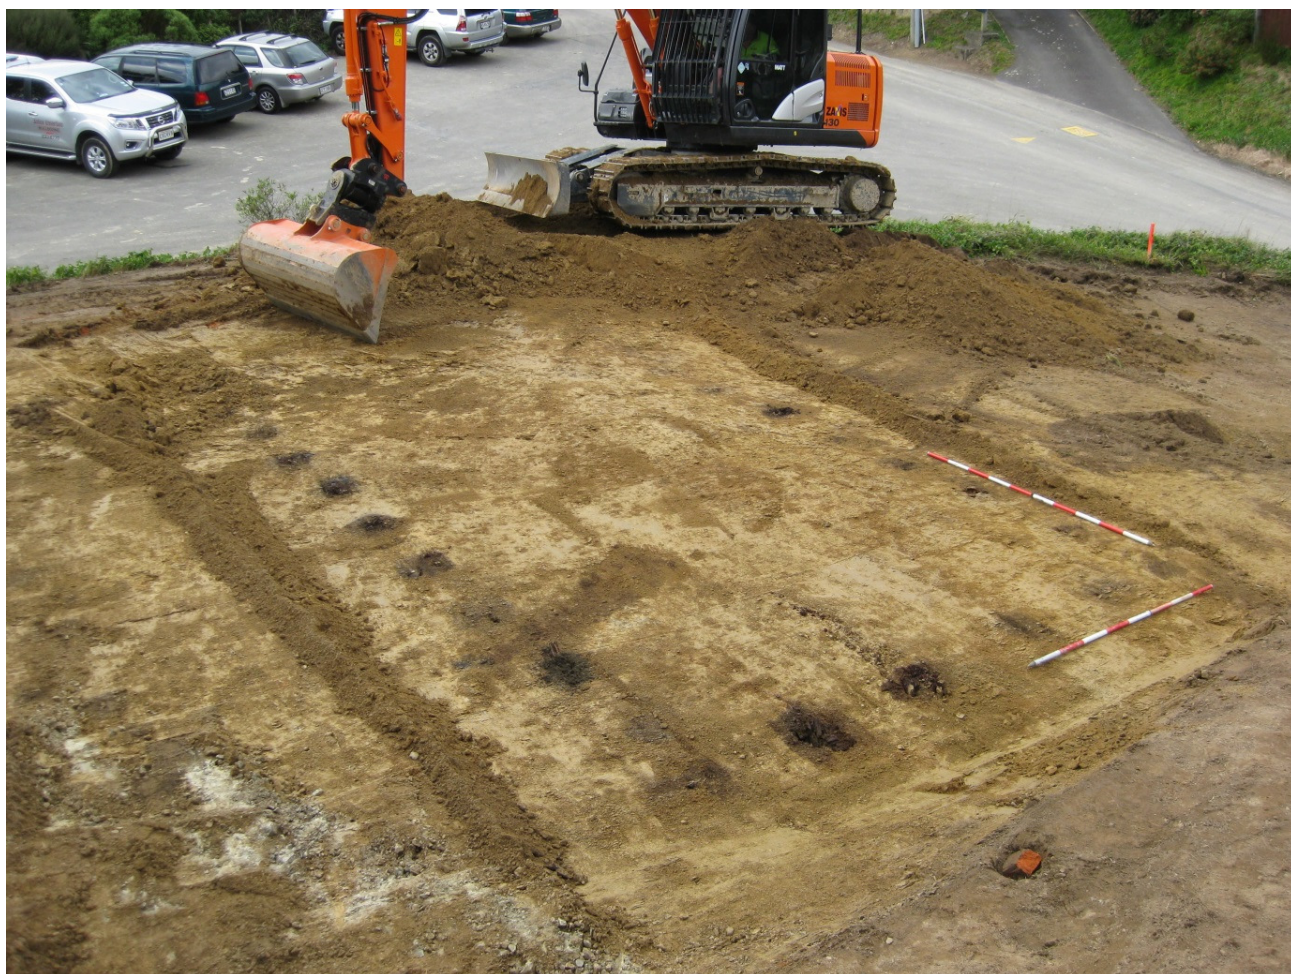
Fig. 17. Reverse view of the above photograph after stripping another spit, view to east. Weathered greywacke bedrock (grey colour) lower left.

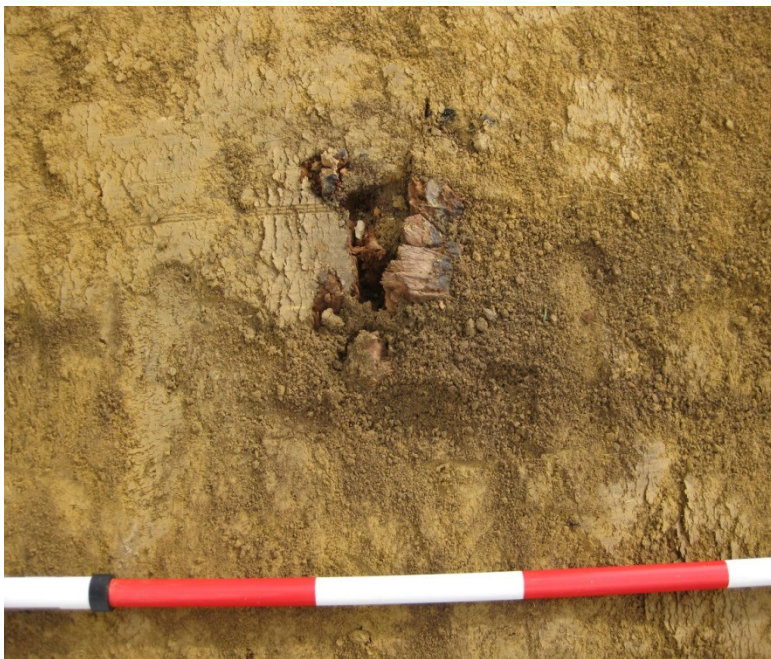
Fig. 18. Pile-hole contents, south-east elevation, showing pile base turned out by digger with charcoal to right. Probably totara.

The wood of the piles appeared to be split totara and puriri (full section of trunk some 30 cm in diameter, Figs 18 - 21). The wood of some piles had a carbonised upper surface, evidence that the house had burned down or that an abandoned site had been burned through. One pile hole near the fireplace had molten glass fragments in it, as if a bottle had been caught in fierce heat and melted glass had run down into the hole.

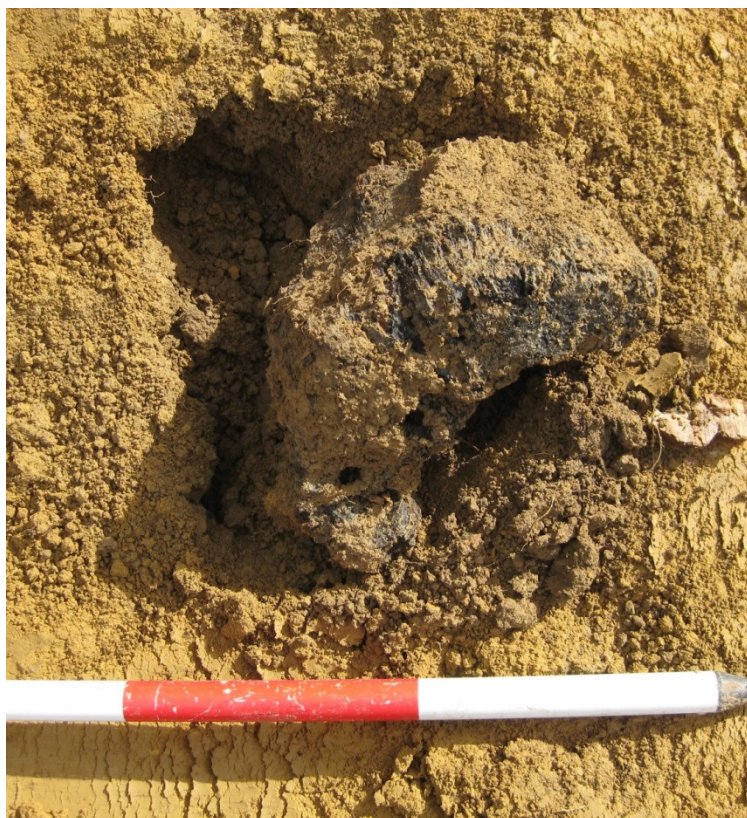
Fig. 19. Pile-hole contents, south-east elevation, showing pile base turned out by digger with sawn base of tree bole showing. Probably puriri.

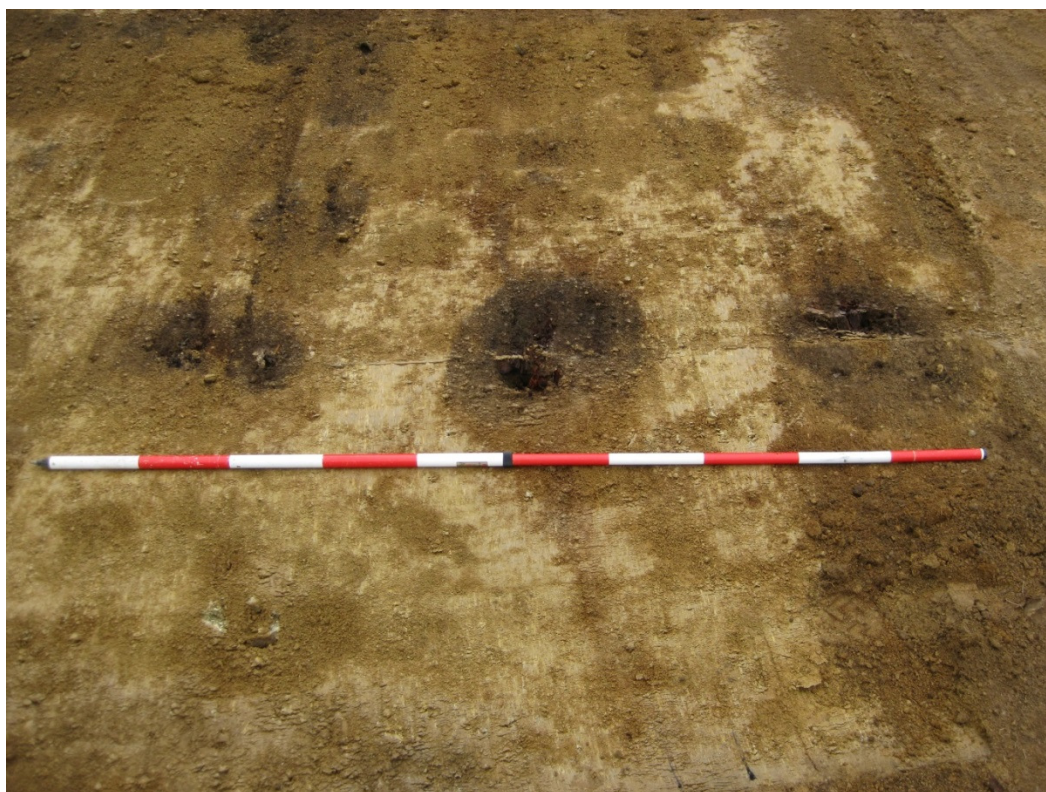
Fig. 20. Typical pile holes, south-west elevation.

The pile hole bases were up to 40 cm square; a few of these with the base of the pile in situ and packed in with earth. Typical outlines were irregular and went to a depth of about 50 cm below the modern surface and perhaps 40 cm below the original levelled terrace surface. A number of the pile holes had bricks on their flats on the upper part of the pile hole. These were probably inserted to brace the wood of the pile above after the piles had rotted at ground level.

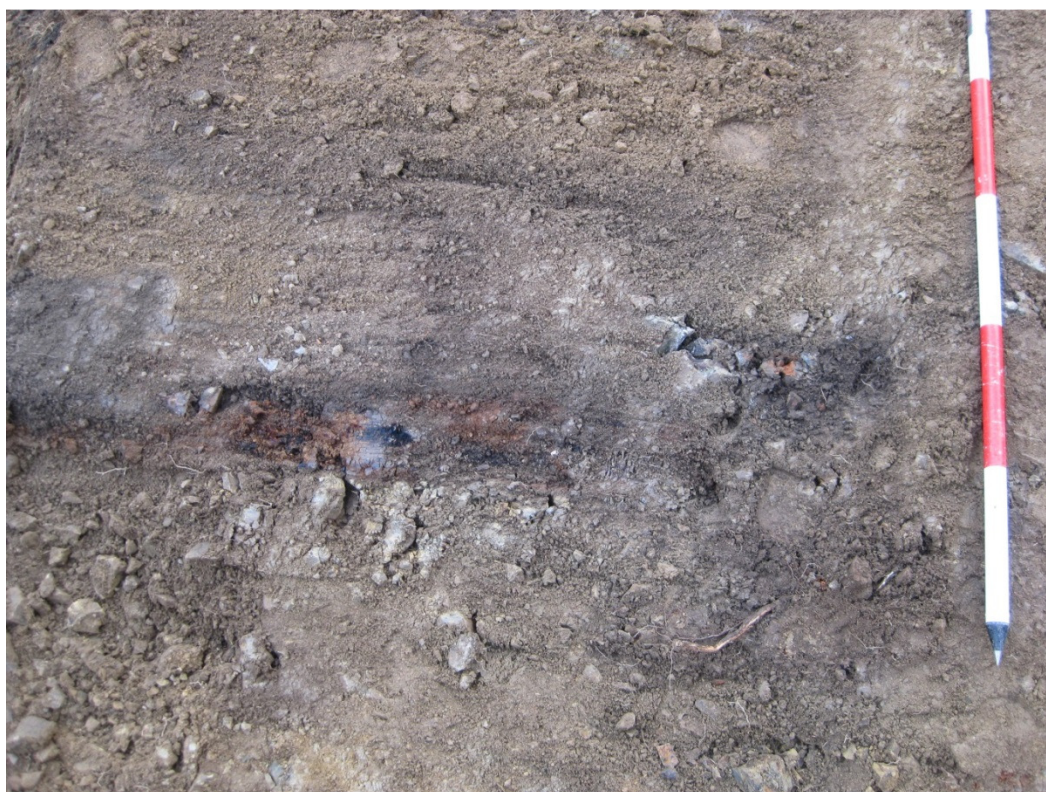
Fig. 21. Organic stain of ground or foundation plate at western corner.

At the western corner (west of the grey soil in-wash) and between the brick chimney base and the eastern corner there were linear remains or organic stains of wooden foundation plates or possibly base plates for wooden framing on piles, collapsed down (Fig. 21). There were no pile holes beneath the linear stains at the north-western corner so it seems probable that this was a foundation plate placed on fairly solid bedrock.

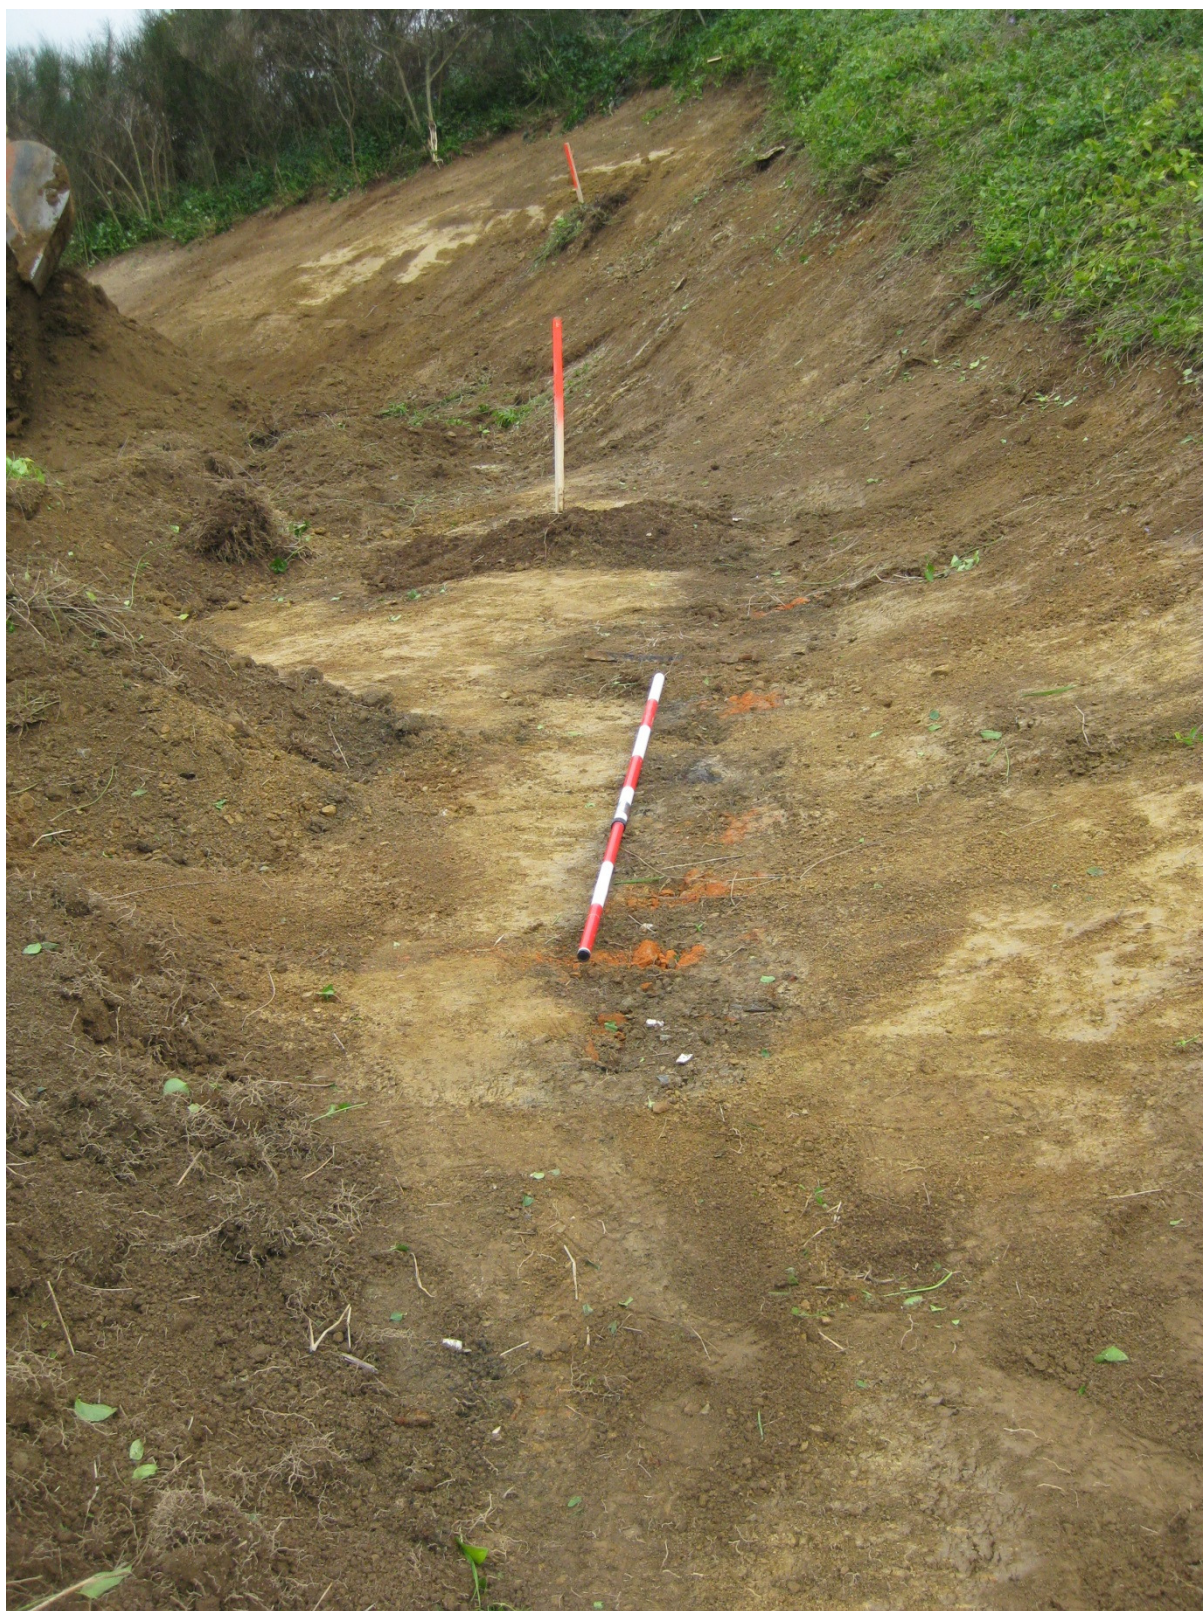
Fig. 22. Brick-lined slope drain above the cottage platform (covered in soil at left). This drain may have carried storm water from the lean-to roof of the cottage (see Fig. 5).

A brick-lined drain above the house was observed in some final scrapings of the house terrace. This may have drained the foot of the slope but seems more likely to have been a surface drain for a downpipe from the north-western eaves of the house (see Fig. 5).

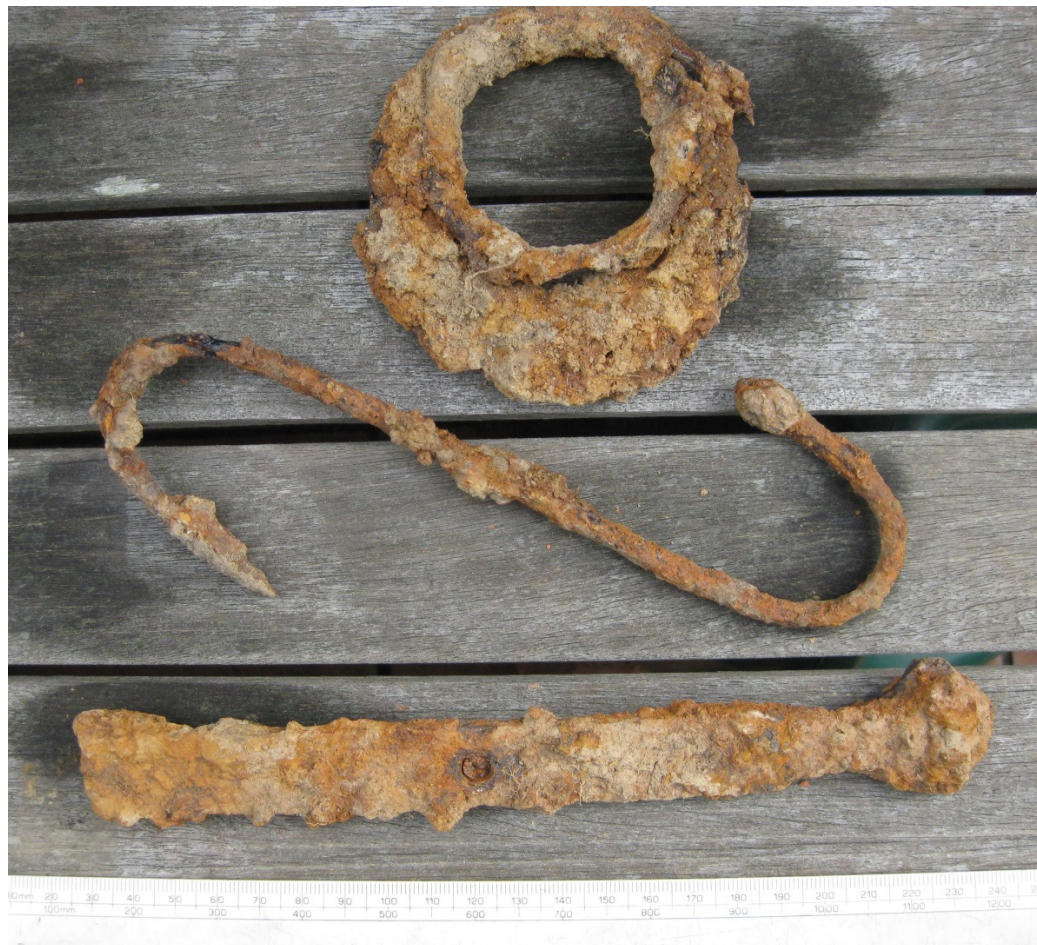
Fig. 23. Iron and copper artefacts. Top: mattress spring, butchers hook, casement-window stay. Bottom: nails, thin copper sheet, mattress spring.

### Iron (Fig. 23)

Several mattress springs were found at the south-western end of the cottage. The diameter of the outer rings was 95 mm.

A small piece of copper or brass sheet was found near the chimney base, less than 0.5 mm thick.

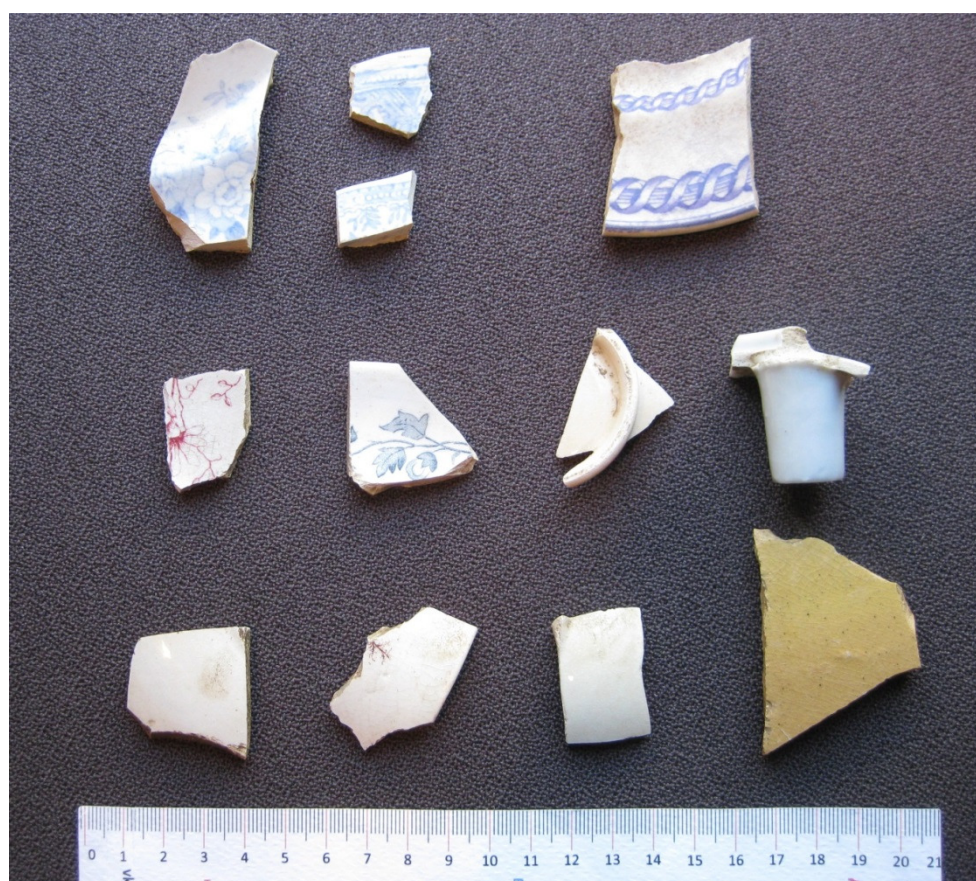
Fig. 25. Ceramic sherds recovered from brick-lined drain. Top row (left to right): Asiatic Pheasants plate, Cable plate. Middle row (left to right): red UGTP vessel, grey UGTP saucer, Bone China cup, unidentified European Porcelain vessel. Bottom row (left to right): Bone China cup sherds, buff-bodied earthenware pie dish.

Table 1. Ceramics, brick-lined drain uphill and to west of cottage.

Style	Vessel form	Fabric	Comment
BW UGTP Asiatic Pheasants	Large dinner plate, 3 fragments	Whiteware	First produced 1834 but uncommon until c.1860s
Purple UGTP Cable	Large dinner plate	Whiteware	Popular in second half of 19 <sup>th</sup> century
Light crimson UGTP flower motif		Stoneware china	Date c. 1890
Grey UGTP ivy motif	Saucer	Stoneware china	Date c. 1890
Undecorated	Saucers, cups, cup bases	Bone China	c.1800 – 1900s
Undecorated	Unidentified vessel	European Porcelain	c.1800=1900s
Undecorated	Pie dish	Buff-bodied Earthenware	c. 1800s - 1950s

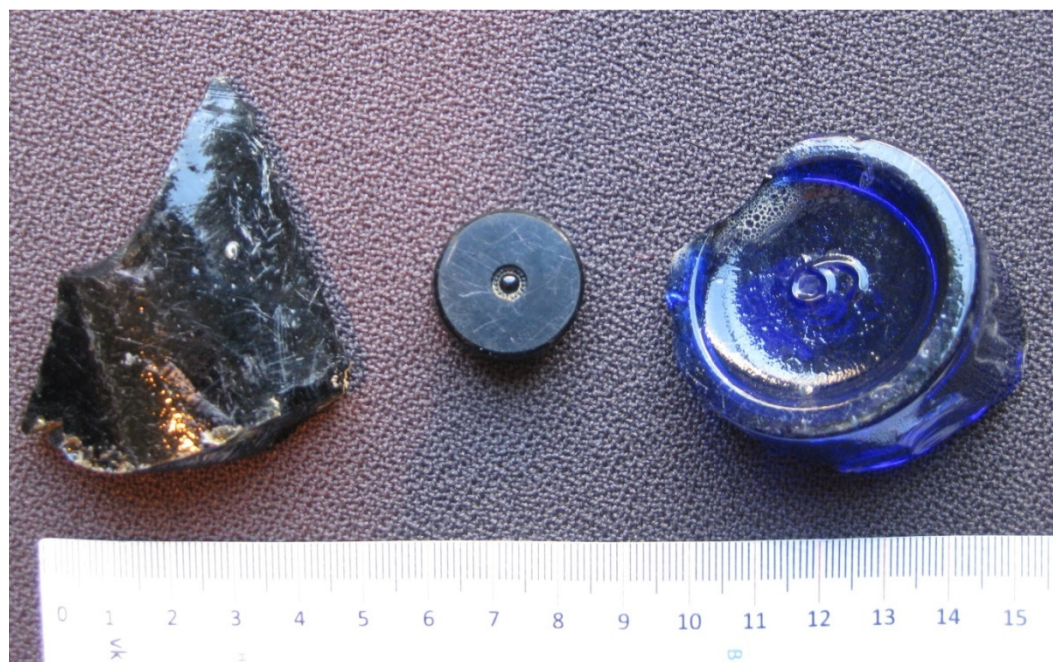
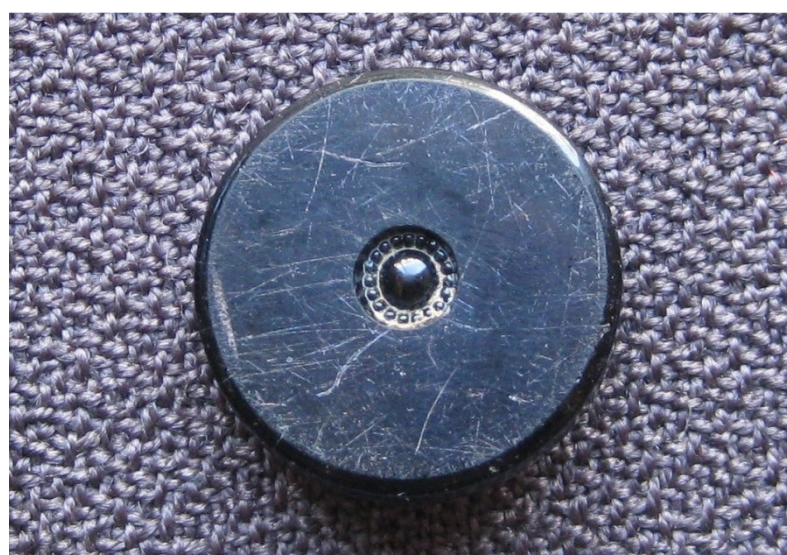
Fig. 26. Glass artefacts collected from brick-lined drain. Top image (left to right): “Black beer” bottle, button, cobalt blue medicine bottle.

Table 2. Glass, brick-lined drain uphill and to west of cottage.

Style	Vessel form	Fabric	Comment
Black beer	Bottle bottom end, dip moulded		c.1830 - 1860
Opaque black glass	Glass button with copper fixing	Opaque glass	Diameter 22 mm Thickness 3 mm, small recessed glass boss at centre
Cobalt blue glass	Small medicine bottle, e.g. milk of magnesia or castor oil, cup-bottom mould		Diameter 42 mm, two-piece mould mark, 1850 – 1900. Mould mark 6 on base.

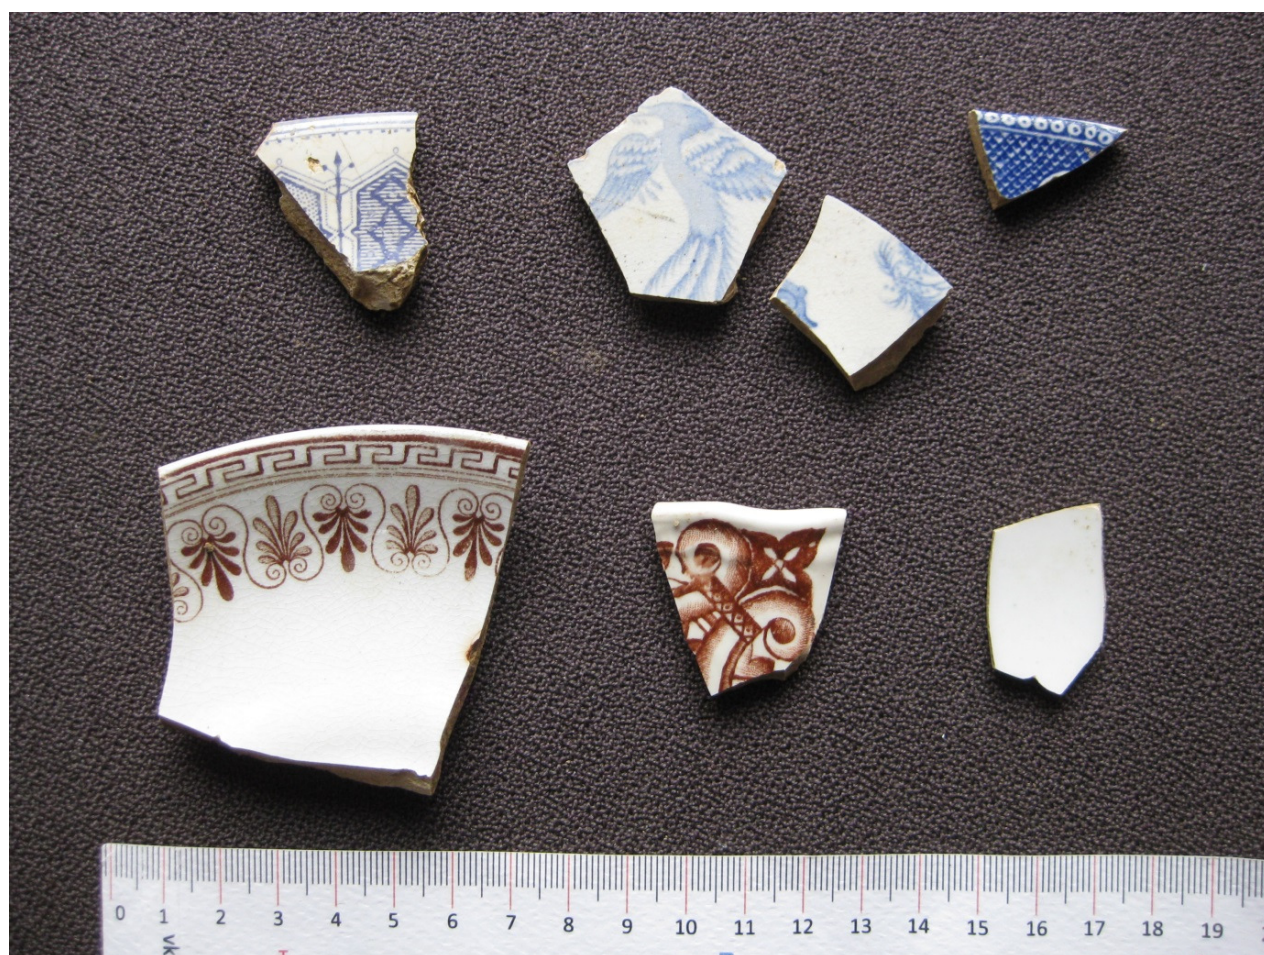
Fig. 27. Ceramic sherds from K2 K3. Top row (left to right): Gothic UGTP plate, Asiatic Pheasants plate, Willow plate. Bottom row (left to right): brown UGTP saucer, brown UGTP jug, undecorated vessel.

Table 3. Ceramics, down slope in trench K2 K3 east of cottage terrace.

Style	Vessel form	Fabric	Comment
BW UGTP geometric Gothic pattern on rim	Plate rim	Whiteware	Popular in second half of 19 <sup>th</sup> century
BW UGTP Asiatic pheasants	Two fragments, dinner plate	Whiteware	First produced 1834 but uncommon until c.1860s
BW UGTP Willow Pattern	Fragment dinner plate	Whiteware	1805 – 1900s
Brown UGTP, geometric rim	Saucer	Whiteware	c.1840 - 1880
Brown UGTP, Gothic motif	Jug	Whiteware	c.1840 – 1880 Unusual decoration
Undecorated	Saucer or cup	Stoneware china	1880-1900 Quotidian ware

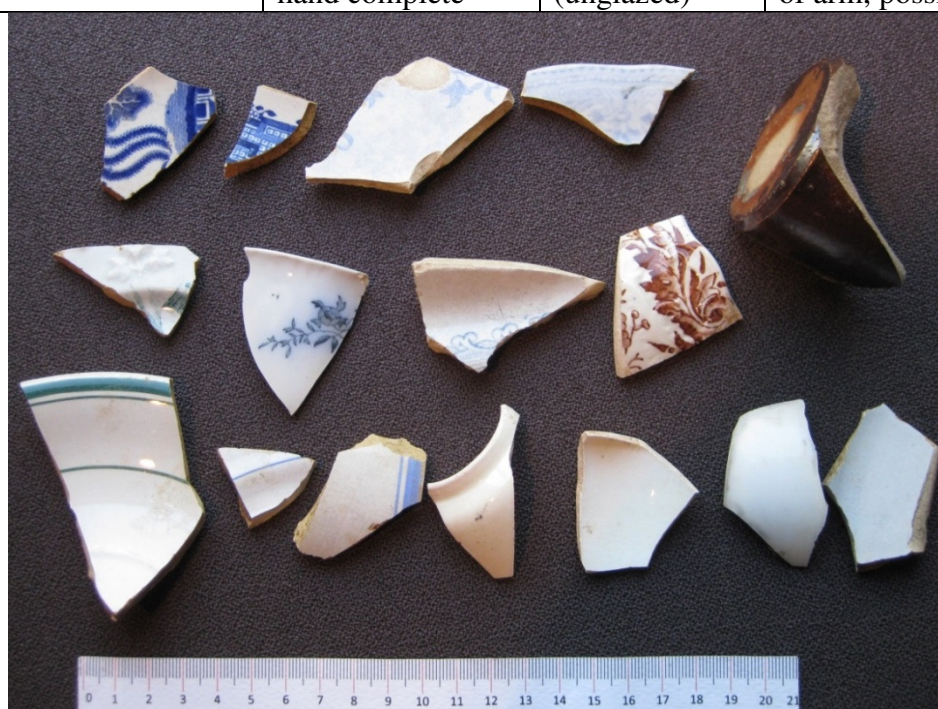
Fig. 28. Ceramic sherds from below topsoil. Top row (left to right): Willow plate, Asiatic Pheasants plate, salt-glazed stoneware vessel. Middle row (left to right): green UGTP plate with embossed marly, Bone China cup, Rhine plate, brown UGTP plate. Bottom row (left to right): green and blue banded ware, Bone China cups.

Table. 4. Ceramics, surface below topsoil, south-eastern slope below cottage terrace.

Style	Vessel form	Fabric	Comment
BW UGTP Willow Pattern	Dinner plates, two frags	Whiteware	1805- 1900s
BW UGTP Asiatic Pheasants	Dinner plates, two frags, scalloped edge	Whiteware	First produced 1834 but uncommon until c.1860s
UGTP light green, flower motif, flower embossed	Dinner plate	Whiteware	1800 – 1860 Embossing on marly
UGTP blue, rambling rose	Cup, flared rim	Bone china	1880 - 1900
UGTP grey Rhine	Dinner plate rim	Whiteware	–Second half of 19 <sup>th</sup> century
UGTP brown Acanthus motif, embossed pattern, rim scalloped	Mug rim	Whiteware	1805 - 1900
Brown salt-glazed stoneware jar	Base of small bottle	Salt-glazed stoneware	c.1830s – 1920 56 mm diameter
Blue and green banded wares	Bowl, plate, cup	Stoneware china	1880 - 1900
Undecorated	Cups	Bone china	1800 – 1900
Off-white china bisque	Dolls arm and hand complete	China bisque (unglazed)	Numerals ‘5/0’ at end of arm, possibly a size?
