**Archaeology of R27/392, 1 Stebbings Road,  
Glenside, under Heritage NZ authority 2014/119, for  
Stebbing's Farmlands Ltd.**

**Kevin L. Jones**  
**Kevin L. Jones Archaeologist Ltd**  
**6/13 Leeds Street**  
**WELLINGTON 6011**  
**kenx1000@gmail.com**  
**22 August 2018**

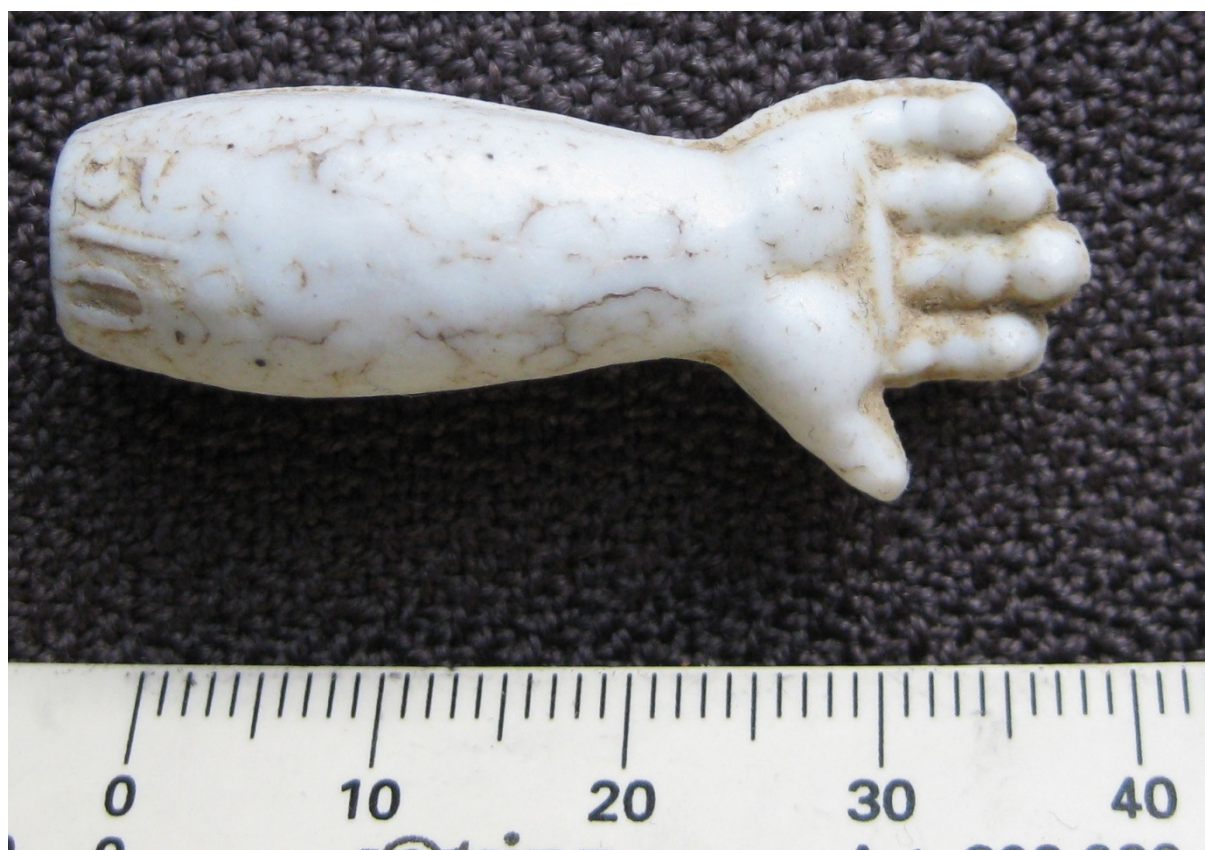
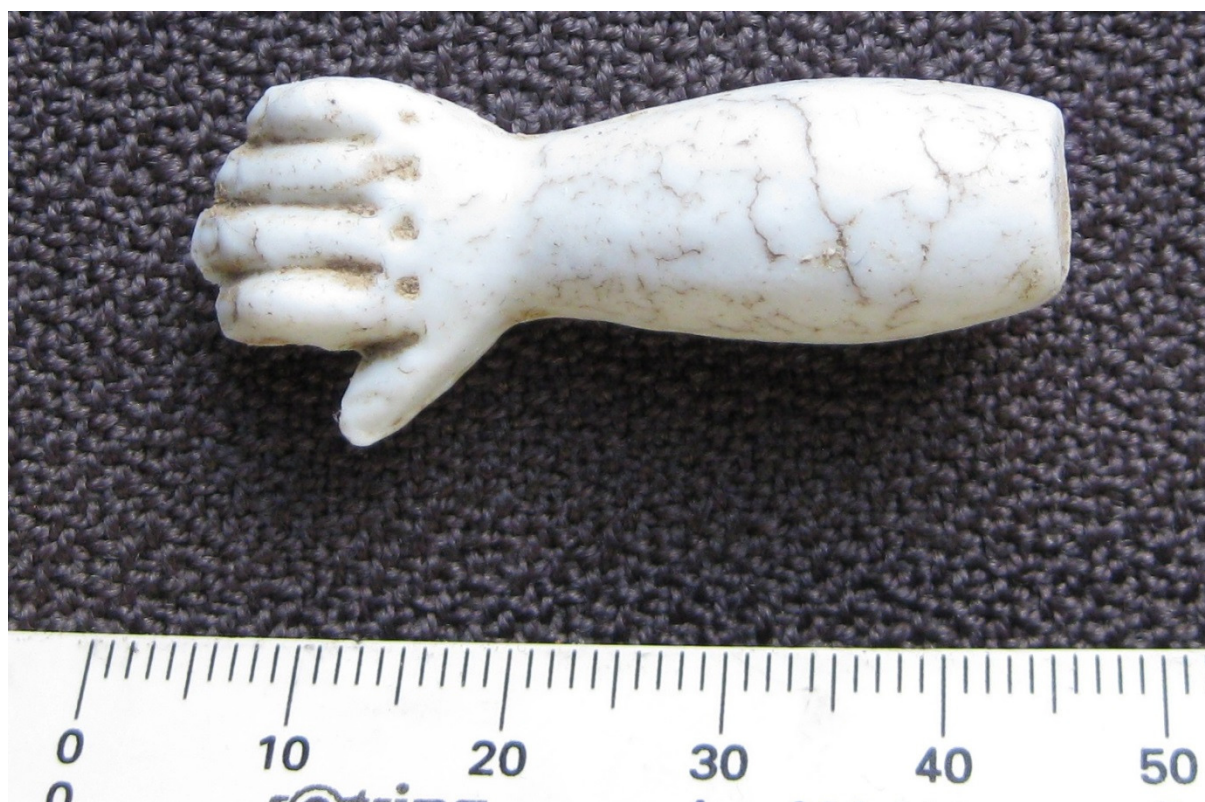
Fig. 29. Ceramic doll's arm, surface below topsoil, south-eastern slope below cottage terrace.

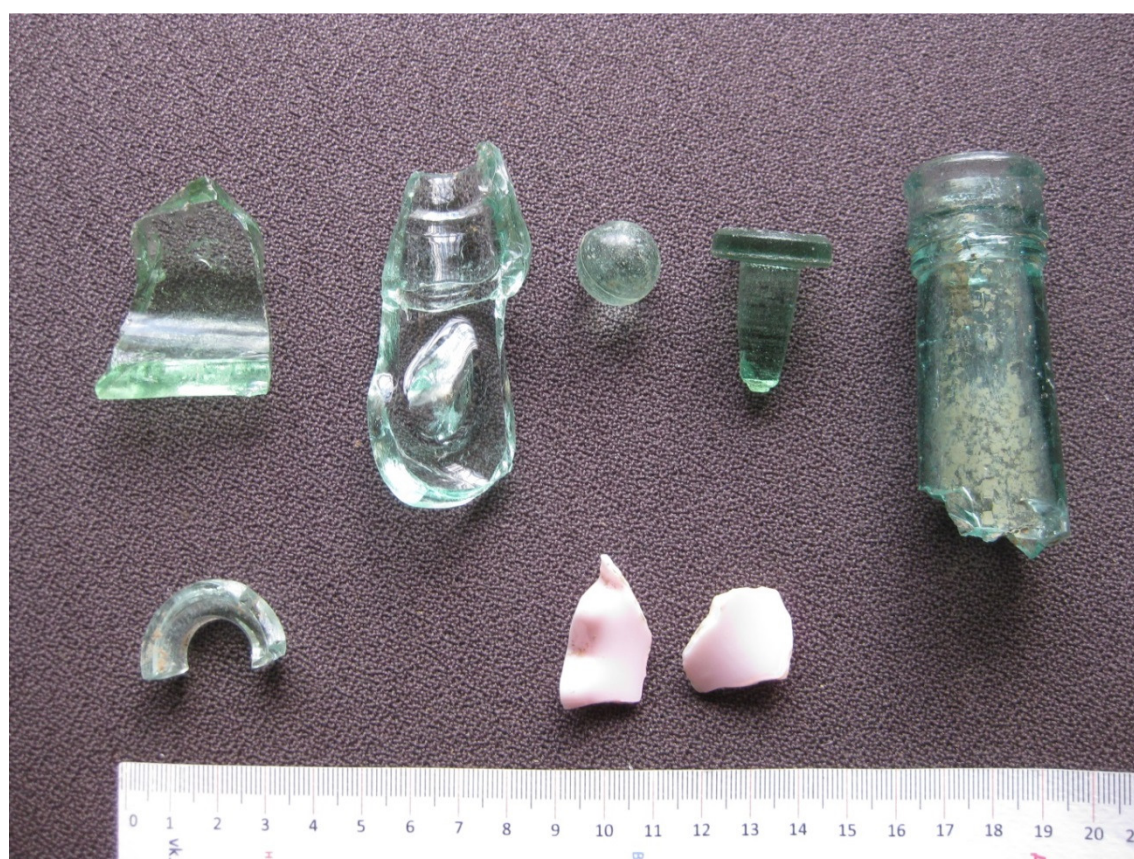
Fig. 30. Glass vessels from below topsoil. Top row (left to right): Codd bottle fragments and marble, glass stopper, club sauce finish. Bottom row (left to right): Codd bottle lip, opaque lamp shade fragments.

Table. 5. Glass, surface below topsoil on south-eastern slope below cottage terrace.

Style	Vessel form	Fabric	Comment
Green glass Codd	Neck and finish, marble		-1872-1930s
Green glass bottle, applied club sauce finish	Neck and finish		1850 – 1900s
Green glass stopper			1850 - 1900
White opaque glass, pink blush on exterior	Rim of lamp shade or mantle, scalloped edge		1850 - 1900

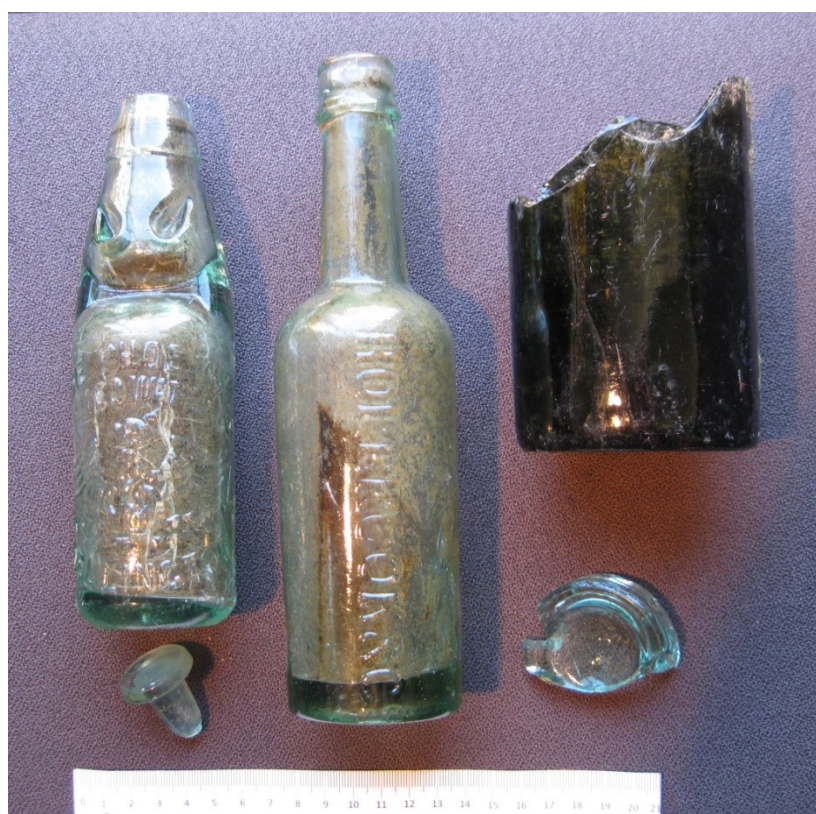
Fig. 31. Glass vessels from western topsoil and brick paving area (left to right): Phoenix Aerated Water Co. Codd bottle (top), glass stopper (bottom), Holbrook Worcestershire sauce bottle, “black beer” (top), aqua bottle base (bottom).

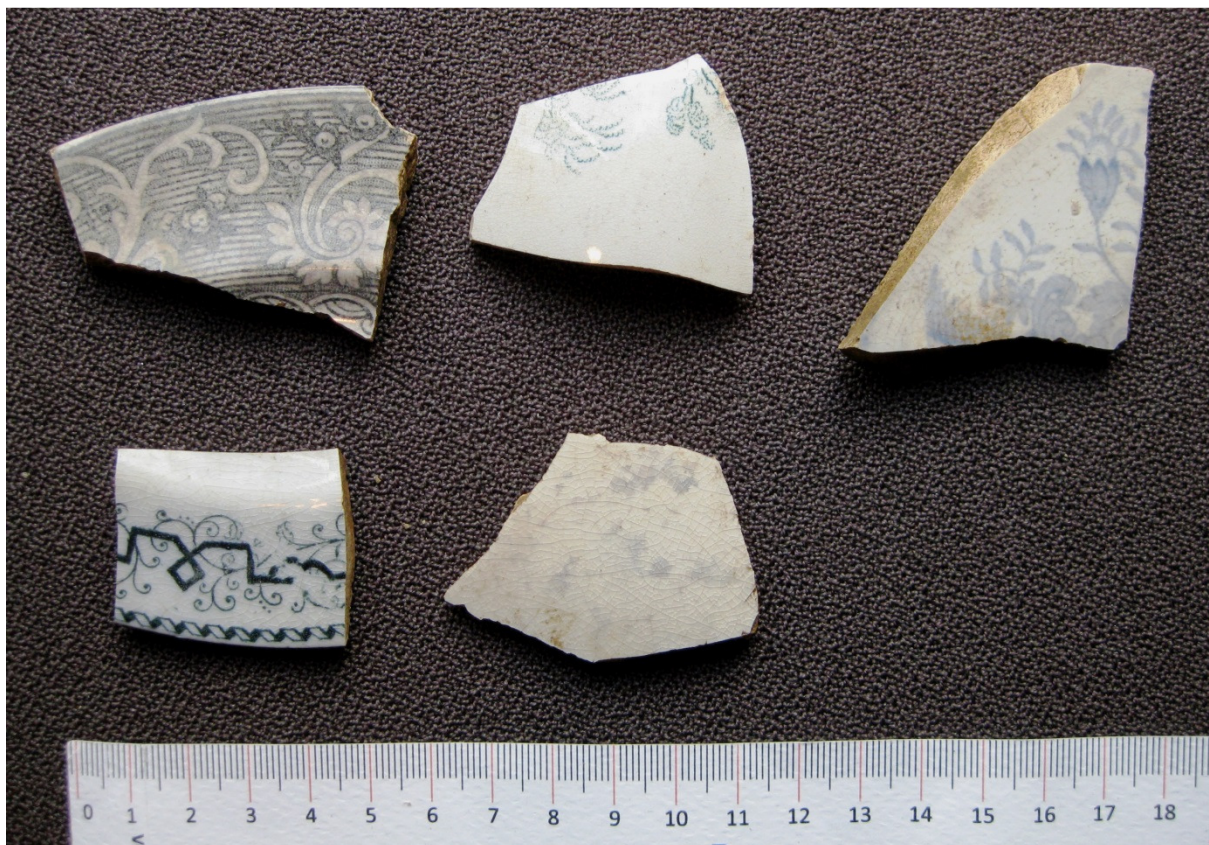
Fig. 32. Ceramic sherds from western topsoil and brick paving area (clockwise from top left): Rhine plate, green UGTP bowl, Asiatic Pheasants plate, whiteware jar, dark blue UGTP plate.

Table 7. Ceramics, western topsoil rectangle and brick paving areas.

Style	Vessel form	Fabric	Comment
UGTP grey Rhine	Dinner plate	Whiteware	–Second half of 19 <sup>th</sup> century
UGTP green plum blossom	Bowl rim	Whiteware	c.1840 - 1890
BW UGTP Asiatic Pheasants	Dinner plate rim	Whiteware	First produced 1834 but uncommon until c.1860s
UGTP dark blue geometric and ribbon motif on rim	Dinner plate	Whiteware	c.1840 - 1890
Undecorated	Jar	Whiteware	1805 – 1900s mould (organic) patterns under crazed lead glaze

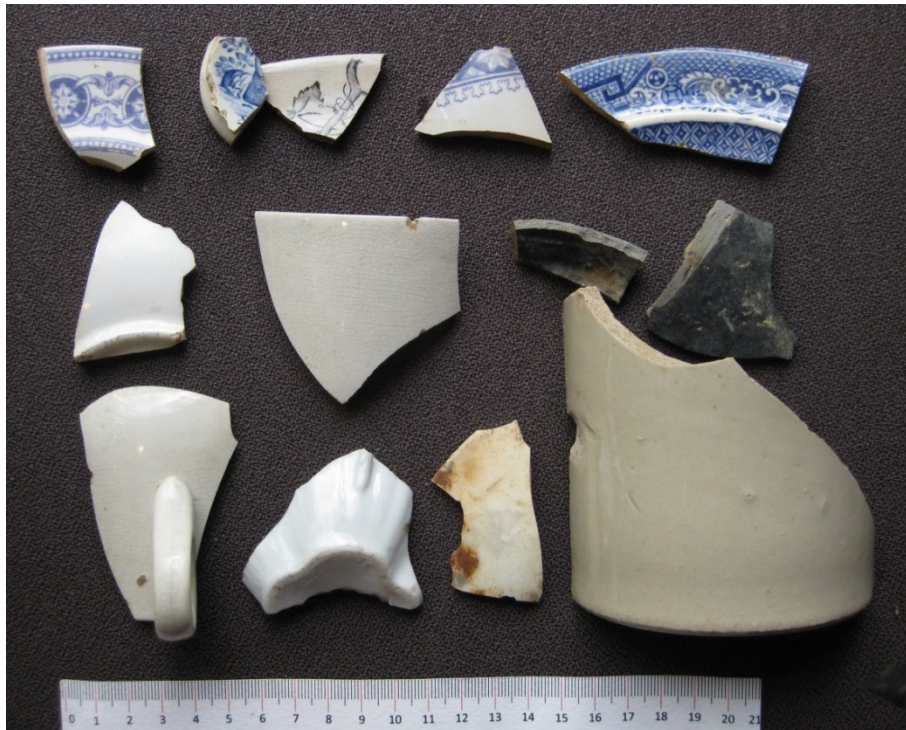
Fig. 33. Ceramic sherds from under cottage. Top row (left to right): blue UGTP plate, blue UGTP cup, blue UGTP saucer, blue UGTP cup, Willow plate. Middle row (left to right): undecorated whiteware cups, possible Chinese vessel. Bottom row (left to right): undecorated whiteware cup, European Porcelain jug, Bone China saucer, slip-glazed stoneware bottle.

Table 8. Ceramics from under cottage area.

Style	Vessel form	Fabric	Comment
BW UGTP banding and medallions	Dinner plate	Whiteware	c.1840 - 1890
BW UGTP 'Country scene'	Base of cup	Whiteware	-1805-1900s
BW UGTP ivy or star motif	Saucer	Whiteware	c.1840 - 1890
BW UGTP Willow Pattern	Shallow bowl/platter or small plate, scalloped edge	Whiteware	-1805-1900s
Undecorated	Cups, saucers	Whiteware	1880s-1900s
White moulded	Fancy cup or milk jug	European Porcelain	c.1800 – 1900s
Undecorated	Saucer rim, damaged in house fire?	Bone China	1800-1900
Cream salt-glazed small crock or bottle	Bottle	Slip-glazed Stoneware	c.1850 – 1920 Diameter 93 mm
Grey stoneware with rough black glaze	Chinese preserves jar?	Stoneware, two fragments, possibly burnt	Chinese village manufacture?

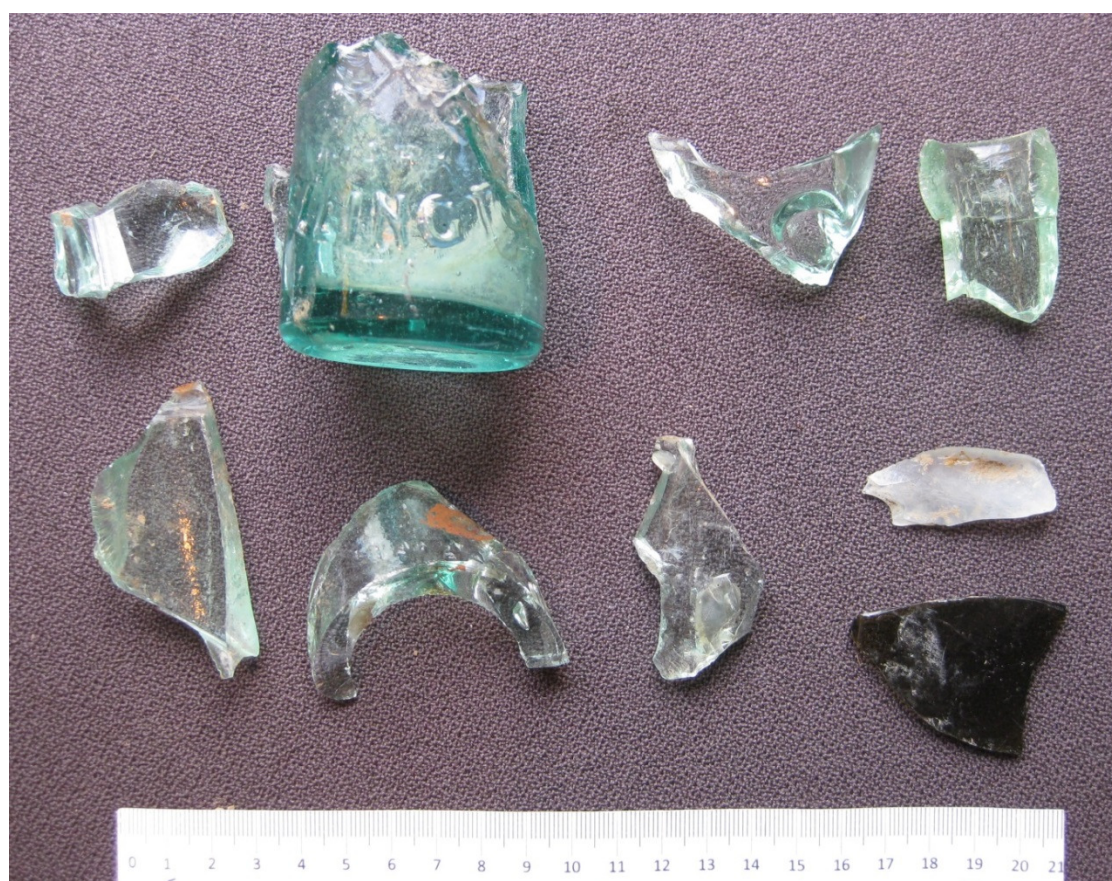
Fig. 34. Glass fragments from beneath cottage (left to right): Thomson & Lewis Codd fragments, blob-top soda finish (top), kerosene lantern glass (middle), case gin bottle (bottom).

Table 9. Glass from under cottage area.

Style	Vessel form	Fabric	Comment
Green glass	Codd and applied lip fragments (MNV = 2). One embossed keys MARK WELLINGT [ON] on base makers mark CWB. Another: [CANN]INGTON SHAW & CO. Also embossed TH[OMSON LEWIS??] AE[RATED WATER]		1889 – 1930s Cannington Shaw & Co. was a UK manufacturer.  Probably a Thomson Lewis & Co Crystal Springs bottle
Aqua green glass	Blob top soda bottle finish		c.1840s-1900
Moulded translucent glass		About 1 mm thick, possibly sand-blasted and with pink colouring	Probably a kerosene lantern mantle 1840 - 1920
Olive green	Case gin, dip moulded		Pre-1880
