**Archaeological assessment of proposed  
work: Halfway House, 246 Middleton  
Rd, Glenside, Wellington**

Report to Wellington City Council

Mary O'Keeffe  
Heritage Solutions  
56 View Rd  
Melrose, Wellington

June 2009

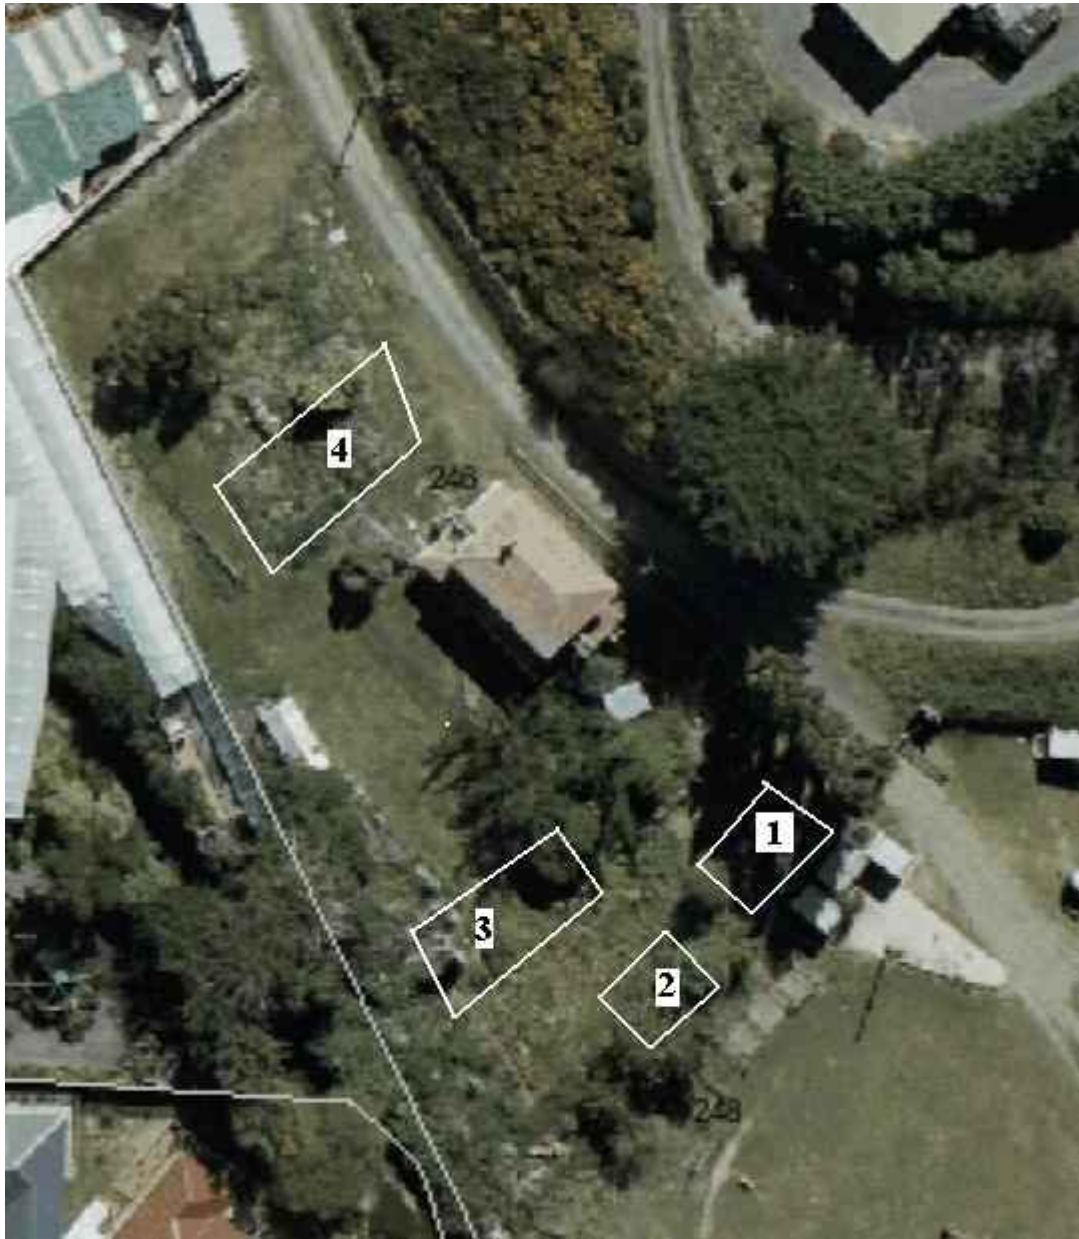
- Area 3: south of the house, between the house and the stream, in the vicinity of the large stump
- Area 4: west of the house

***Figure 10: Areas of disturbance and deposition around Halfway House  
(WCC)***

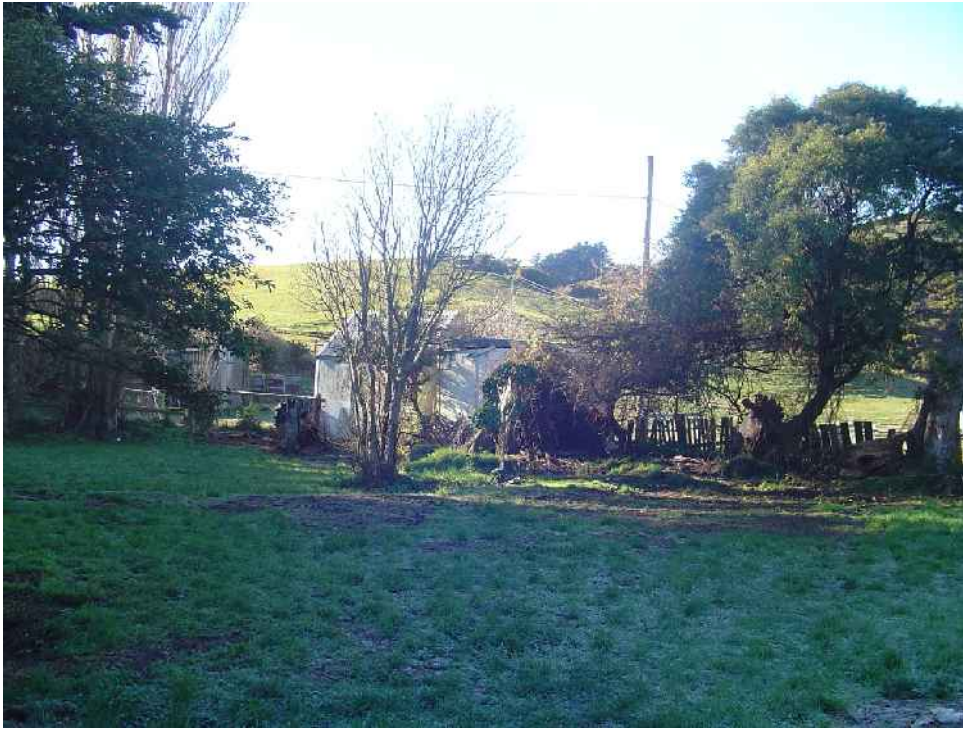
***Figure 11: Areas 1 and 2, east of the house. Looking towards the riding school grounds  
(O'Keeffe, 8-6-09)***

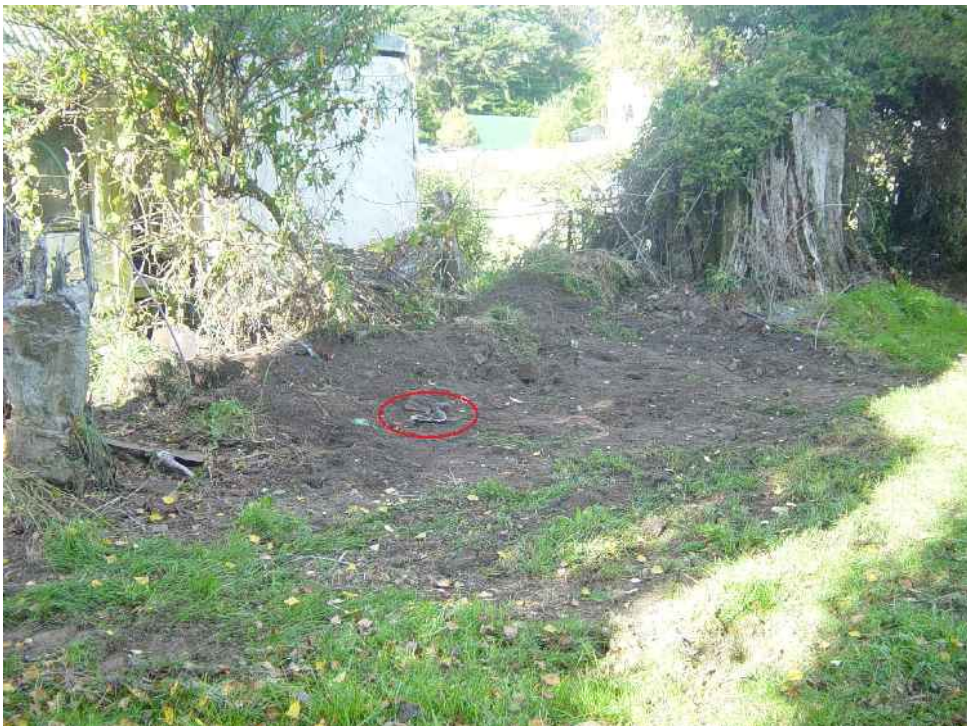
***Figure 12: Area 2 shortly after surface scraping, beside eastern site boundary  
(WCC, 24-4-09)***

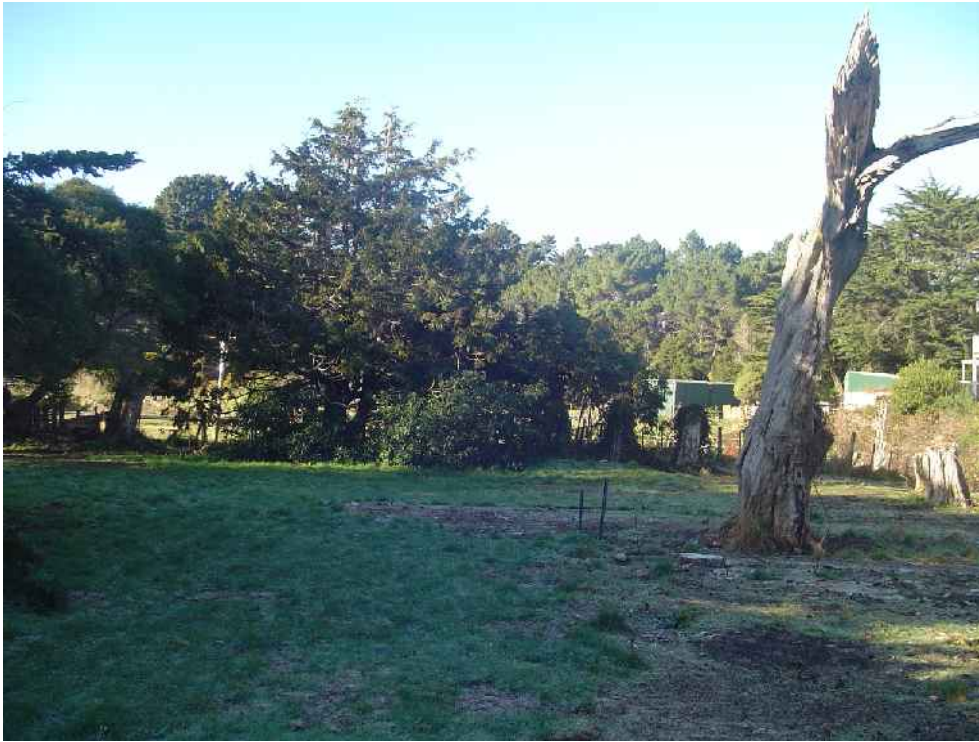
***Figure 13: Area 2, south of the house***  
**(O'Keeffe, 8-6-09)**

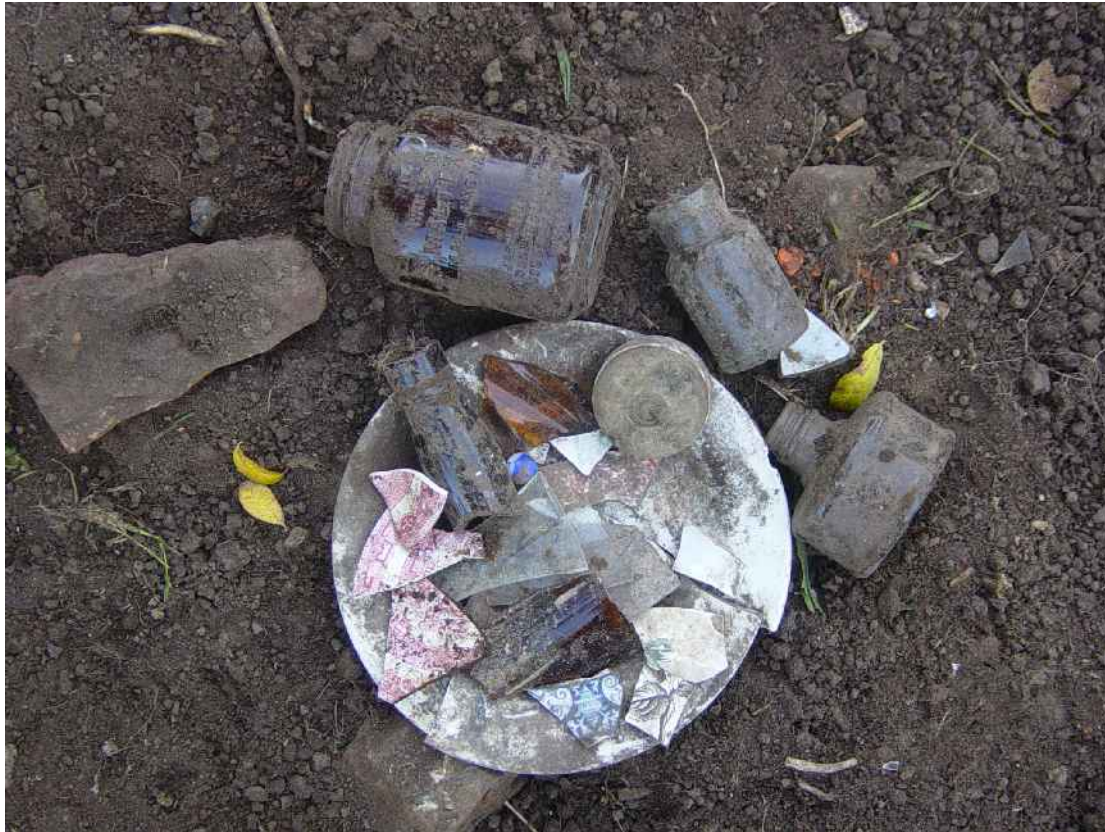
***Figure 15: Surface material recovered by WCC staff***  
(WCC, 24-4-09)

The material that was recovered from the site clearance includes glass objects and fragments, and ceramic fragments. All viewed by the consultant appear to date to the late part of the 19<sup>th</sup> century and into the 20<sup>th</sup> century; no distinctively old forms or patterns were seen.

Other surface debris gathered and piled by the WCC parks and gardens staff include sheets of corrugated iron, and pieces of metal machinery.

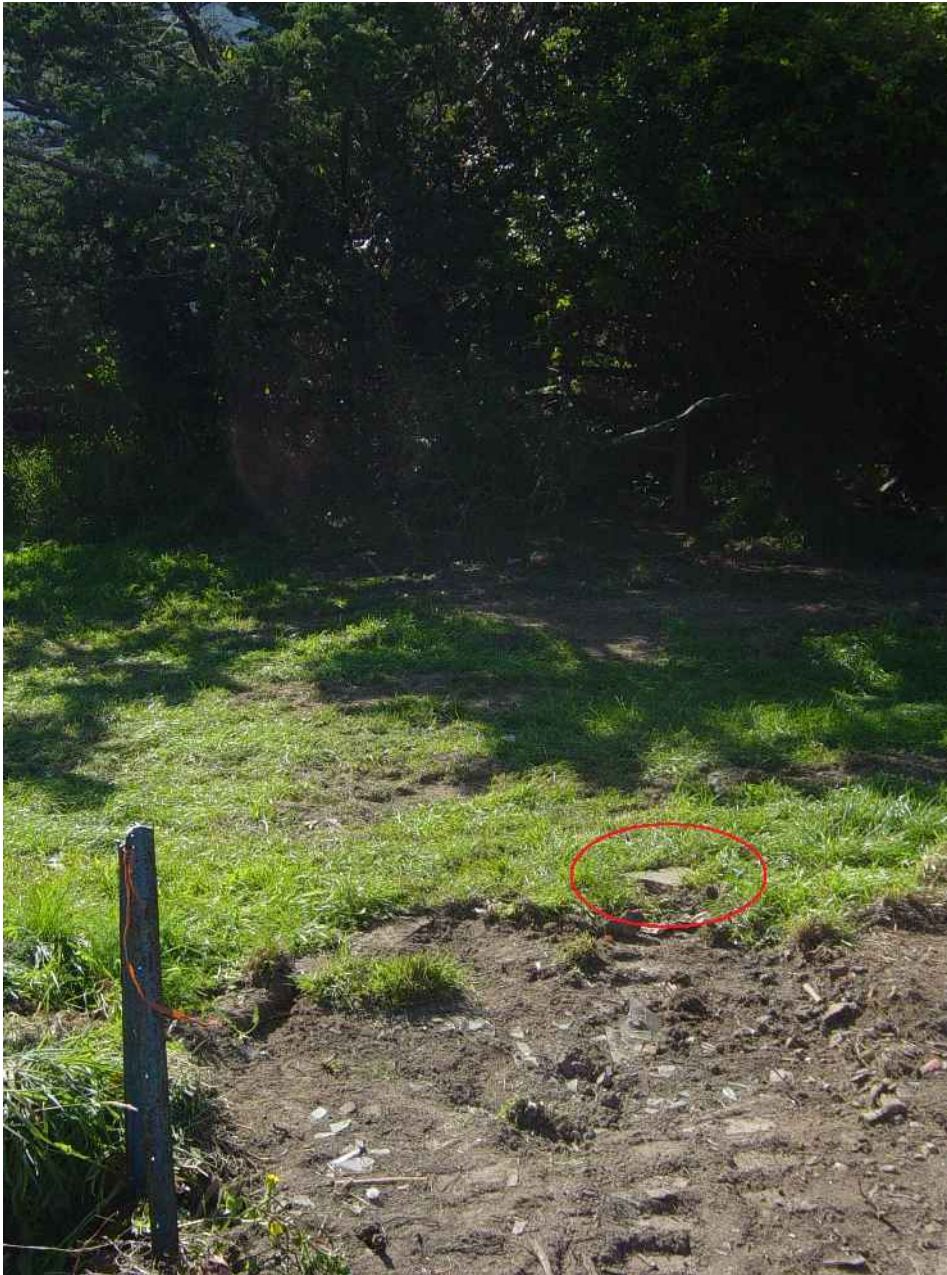
A supposed “grave site” was reported anecdotally to the WCC staff. This seems to be on the basis of a piece of marble that was located in the grounds of the house, on the south side of the house, between the house and stream. There are no records, formal or informal, of a grave in this area. The piece of marble is a flat slab embedded in the lawn; a piece of it has been broken off and is now inside the house. The location of the supposed grave site is under a large macrocarpa on the grass to the south of the house, beside a vertical asbestos pipe under the macrocarpa. Near this was an area of broken concrete and marble..

***Figure 16: Showing edge of marble slab in ground surface***  
**(Claire Bibby, April 2009)**

Whilst no subsurface testing or investigation has been undertaken on this “grave site” it is extremely unlikely to be a grave for two reasons: a grave would not have been placed reasonably close to the house for reasons of hygiene and smell, plus the site is on the lower part of the house grounds near the stream, and thus is in a possible flood zone. A grave would be placed on a higher ridge away from the risk of flood.
