**“Buried with out the burial service”:
archaeological monitoring of possible grave site on the
Westchester Drive extension, Glenside, Wellington,
under HP authority 2010/311 for Wellington City Council**

**Kevin L. Jones
Kevin L. Jones Archaeologist Ltd
6/13 Leeds Street
WELLINGTON 6011
kljarchaeologist@paradise.net.nz**

21 September 2011

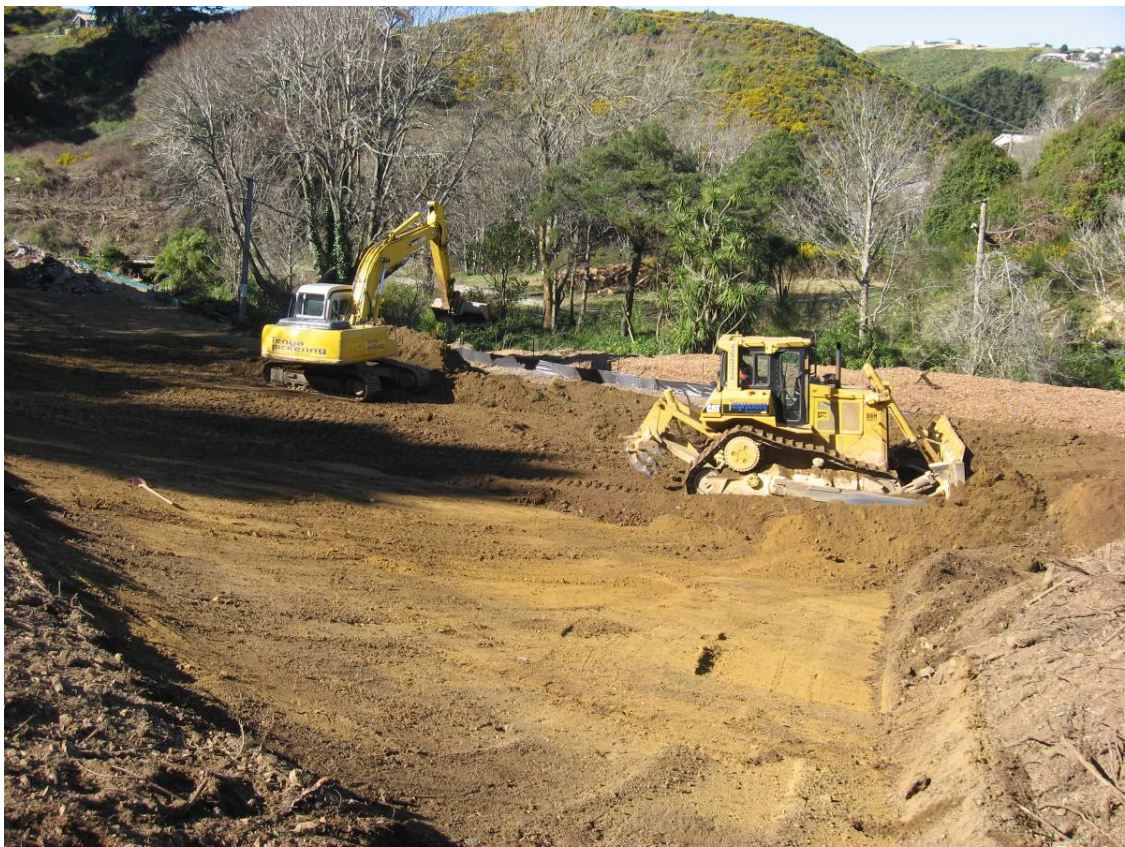
Frontispiece

Looking east over the route of the new road. Glenugie House was on the other side of the Porirua Stream (in the trees).

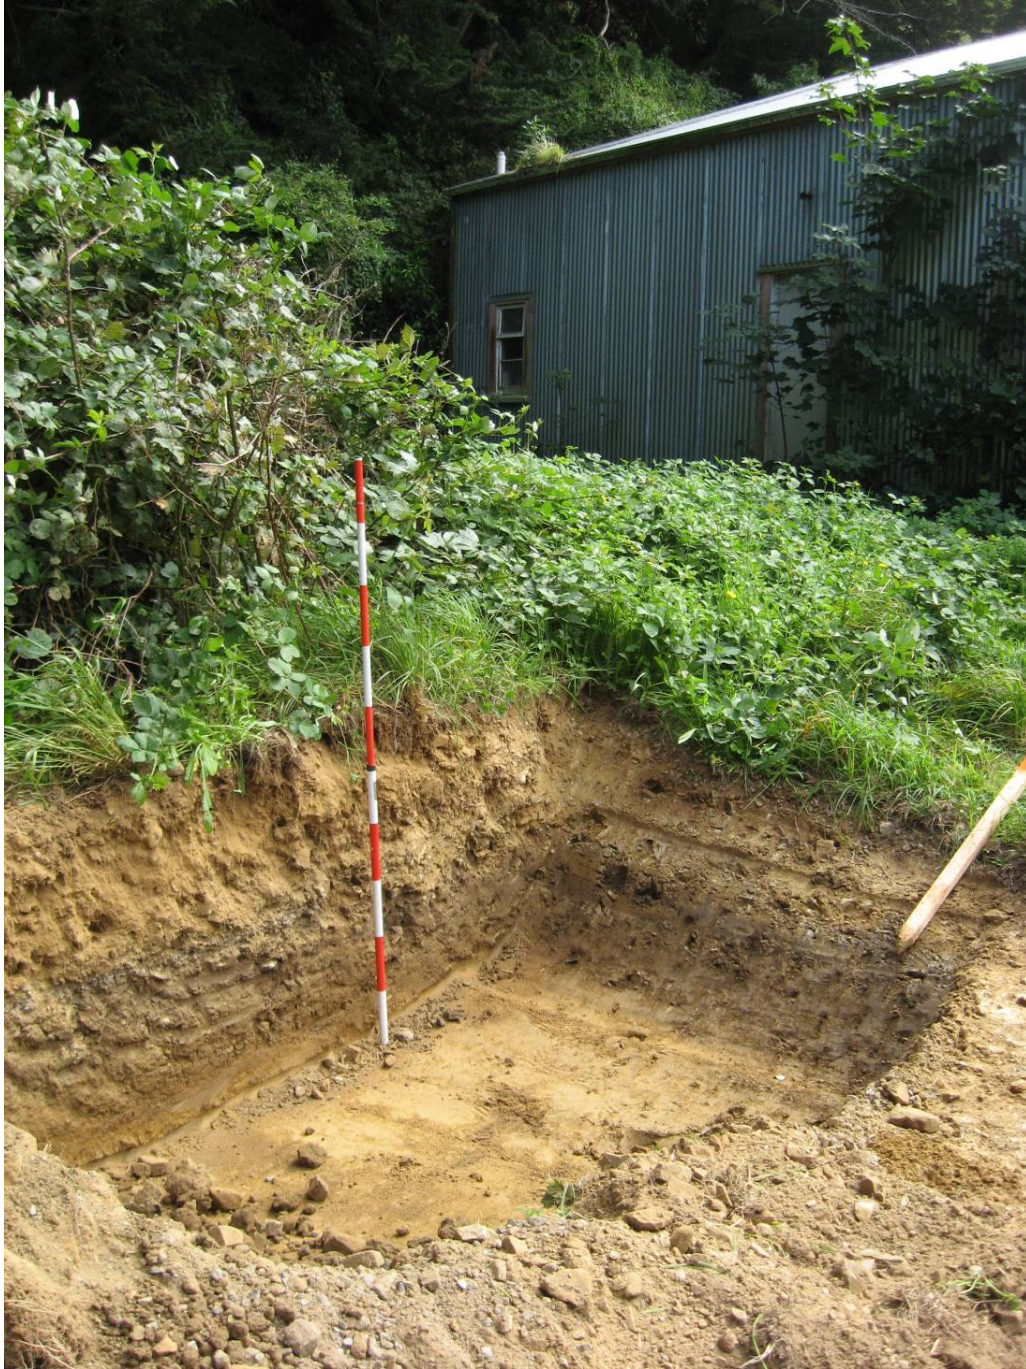
Fig. 4. Engineers' test pit February 2011 showing yellow-brown subsoil and original grey loam topsoil overlain by yellow-brown fill from clearance of the building platform.

There was much fill and landfill with road metal, rubbish and concrete on the margins of the stream. One of the test pits carried out in February 2011 (Fig. 4) showed that the topsoil had been buried by fill cut for the platform on which the corrugated iron house had been built.

In February 2011 working with the engineers I test-pitted areas around the corrugated-iron house (TP on Figure 3, see Figure 4). We also test pitted over a wide area on the knoll or ridge end to the south-west end of the area scraped in September 2011. No trace of a grave was found.

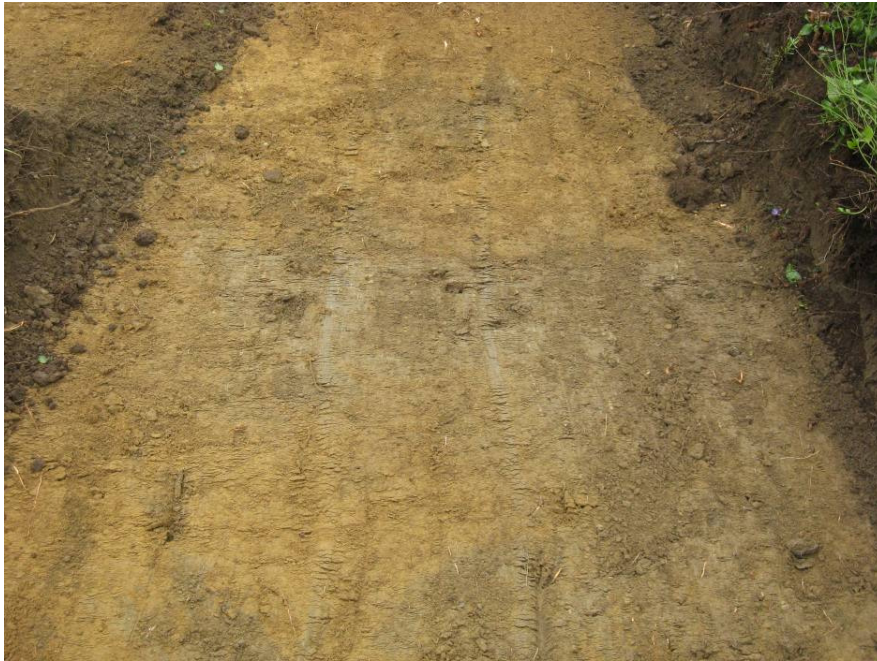
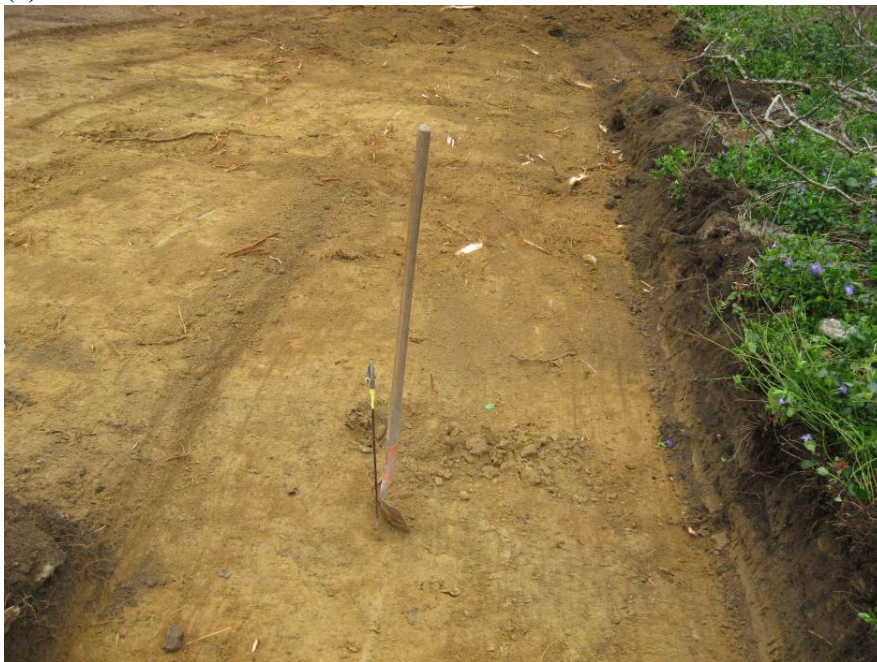
Fig. 5 (a), (b). A grey outline in the yellow-brown subsoil surface (top) disappeared when scraped down a further 10 cm (bottom).

Some areas with semi-rectangular areas of grey subsoil in the surface of the subsoil were dug down a further 10-30 cm deep. In all cases the grey or disturbed soil disappeared (see Figs 5, 6).

outline into the subsoil and then filled in with a mixture of subsoil and topsoil. When the surface of the subsoil is revealed the outline of any grave should show. Examples of scraping producing regular outlines in the subsoil surface are shown in Figures 5 and 6.

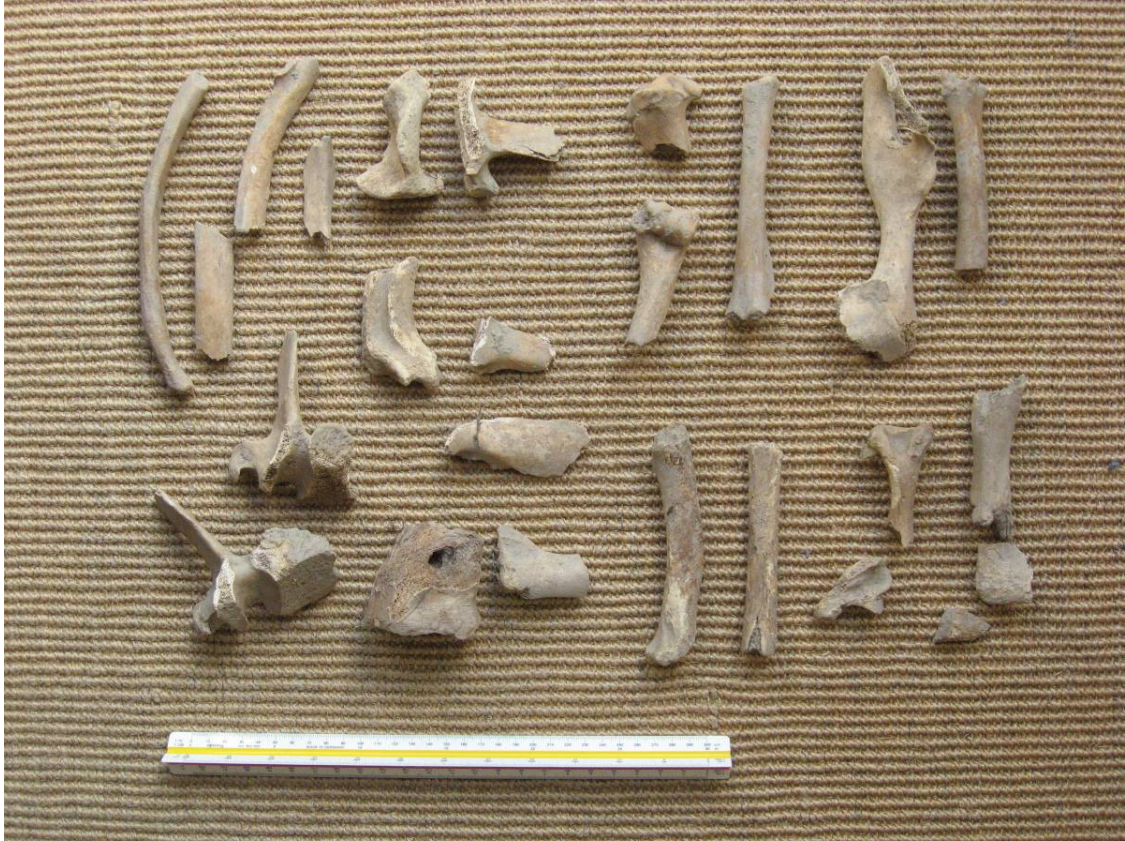
Fig. 11. Bones found in topsoil in the power pole area (BB on Fig. 3). Cattle bones at left, sheep on the right.

In one area near the power pole (BBB in Figure 3) bones became exposed in the topsoil. I left these in position and carried on with the scraping elsewhere. I recovered the bone by trowelling the topsoil. It became clear that it was mixed with plastic and that its final deposition must have been in the last 30 years.

The bone is cattle vertebrae and ribs some with cut edges (soup bones) and sheep tibia and part pelvis (hind leg roast) (Fig. 11). There are other fragmentary bones less easily identified. I assume these are cattle or sheep as well. The bones are in storage and fuller confirmed identification by a forensic anthropologist can be carried out if opinion favours this.
